123 Street
Winnipeg, MB R3N 1H9

INSPECTION DATE
Wednesday, July 9, 2025

Carson Dunlop - The Forman Team

Report No. 1009

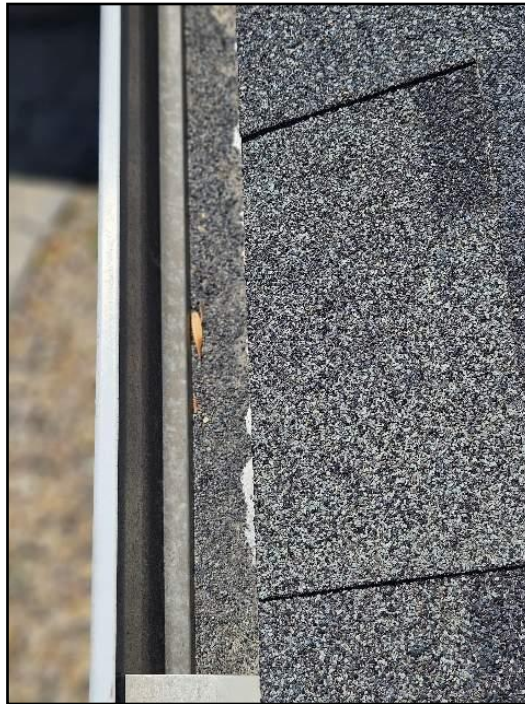
1. Granule loss

1. Condition: • Granule loss

The asphalt shingles are approximately 10 years old and generally appear to be in serviceable condition. Minor granule loss was observed, consistent with age and normal weathering. The roof surface was dry and unobstructed at the time of inspection, allowing for a clear visual assessment.

Task: Monitor

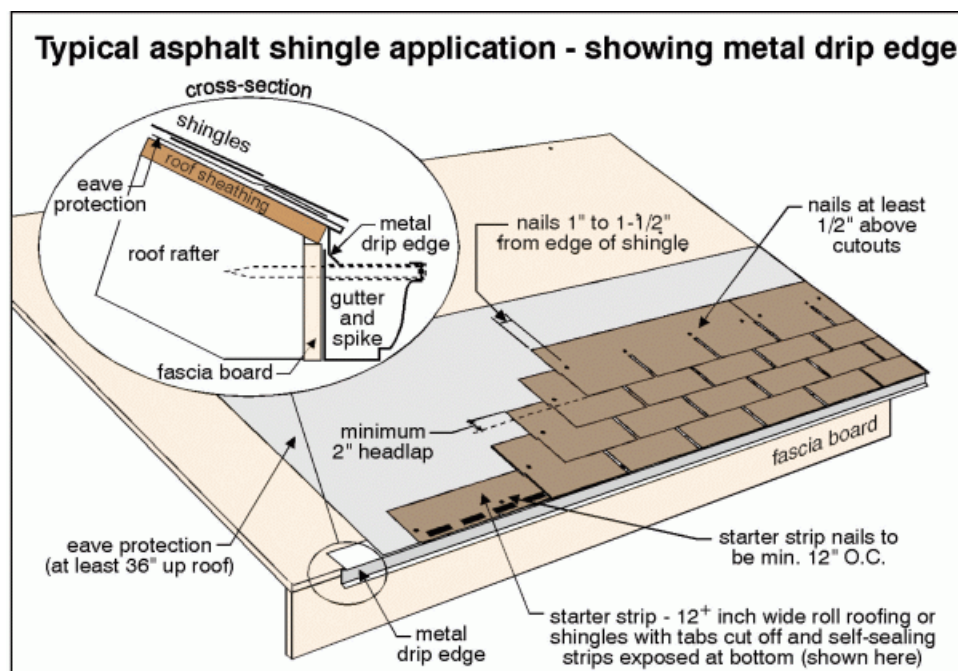
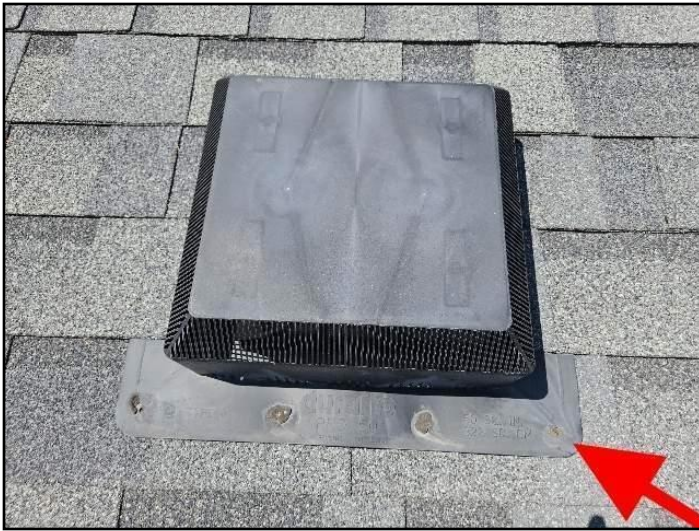
2. Exposed fasteners

2. Condition: • Exposed fasteners

Exposed fasteners were observed on the turtle vent flashing and some areas on the roof surface. Exposed fasteners can allow moisture intrusion and may lead to premature roof deterioration.

Task: Recommend sealing or replacing exposed fasteners with appropriate roofing screws and sealant to prevent potential water infiltration.

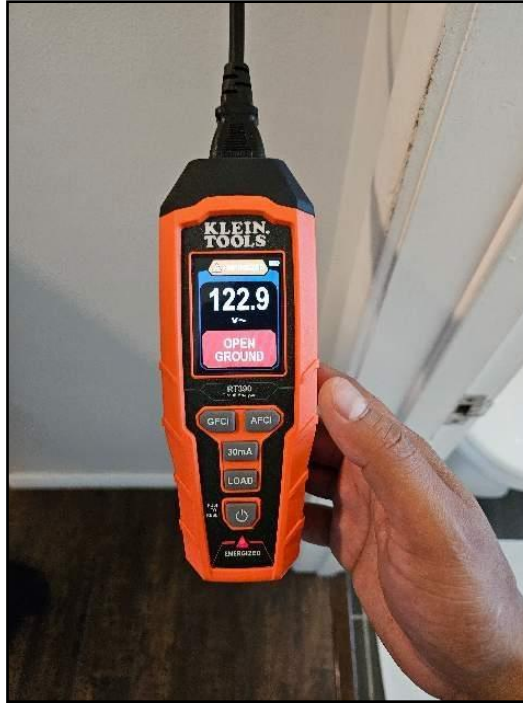
37. Ungrounded - typical

- Ungrounded - typical

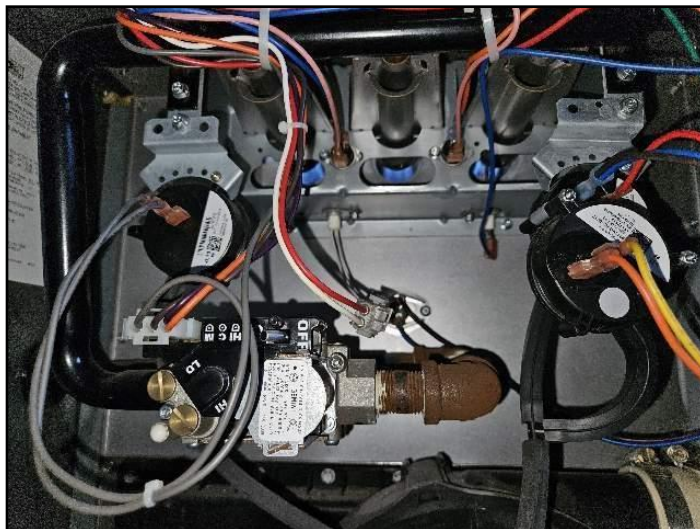
38. Furnace

No issue found with it's performance. Furnace is near end of it's life expectancy.

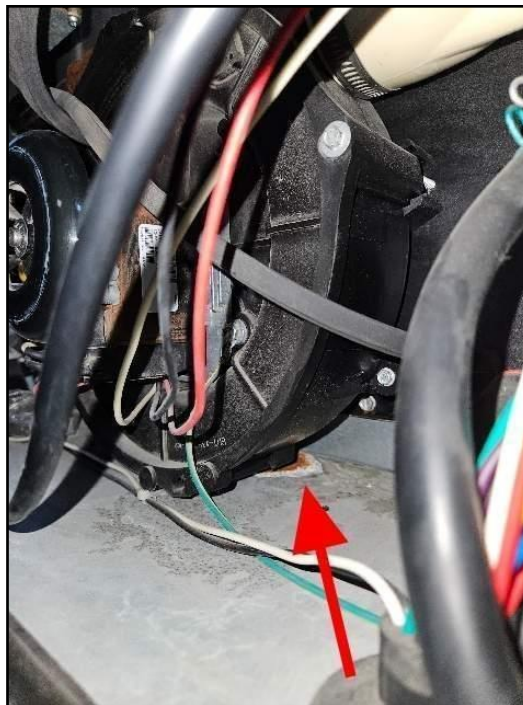
42. Rust

20. Condition: • Rust

Rust was observed inside the furnace cabinet, particularly at the base of the inducer motor assembly. This may indicate previous or ongoing moisture presence within the unit.

Task: Recommend having the furnace inspected by a licensed HVAC technician to determine the source of moisture and assess if any components are affected or require maintenance or repair.

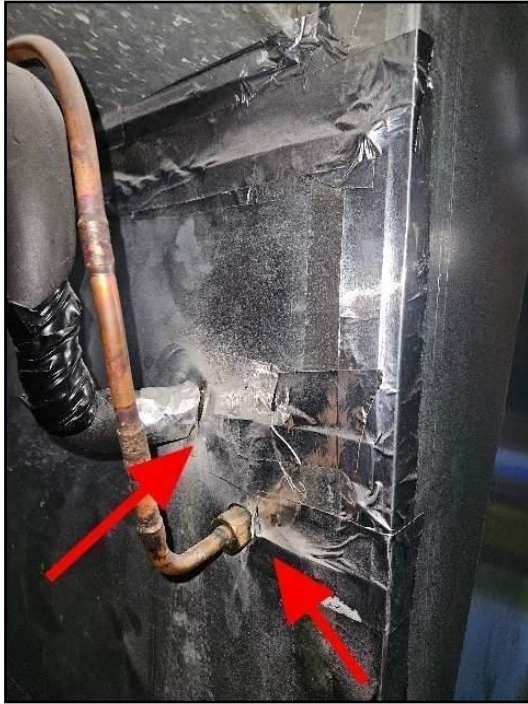
43. Leaky joints

21. Condition: • Leaky joints

Air leakage observed at multiple furnace duct joints.

Task: Recommend sealing the leaking joints using appropriate duct sealant or foil tape to improve system efficiency.

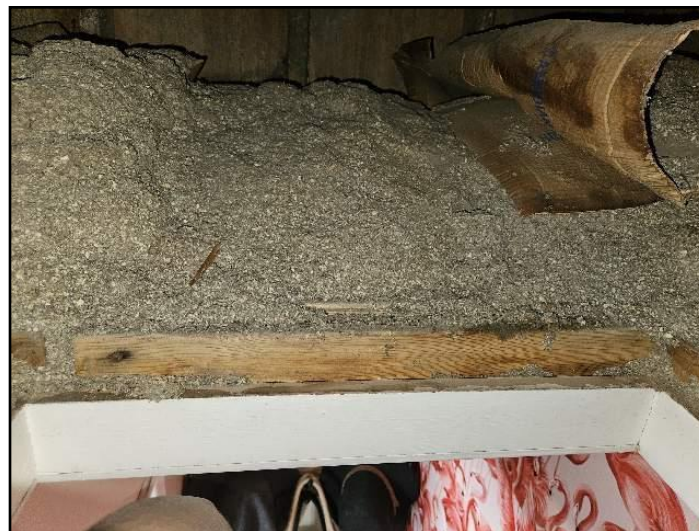
47. Not weatherstripped

24. Condition: • Not weatherstripped

The attic access hatch is not weatherstripped, which may allow air leakage between the conditioned living space and unconditioned attic.

Task: Recommend installing appropriate weatherstripping around the attic hatch to reduce heat loss, improve energy efficiency, and minimize moisture movement into the attic space.

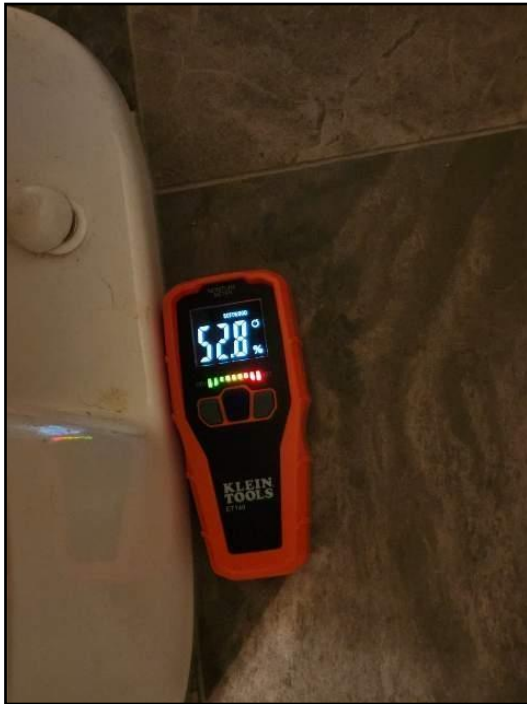
61.

25. Condition: • Elevated moisture levels detected on the floor using a moisture meter after flushing the both toilets, indicating possible plumbing leakage.

Implication(s): Undetected plumbing leaks can lead to water damage, mold growth, structural deterioration, and increased utility costs if not addressed promptly.

Task: Recommend further investigation by a licensed plumber to identify the source of the leak and perform necessary repairs.

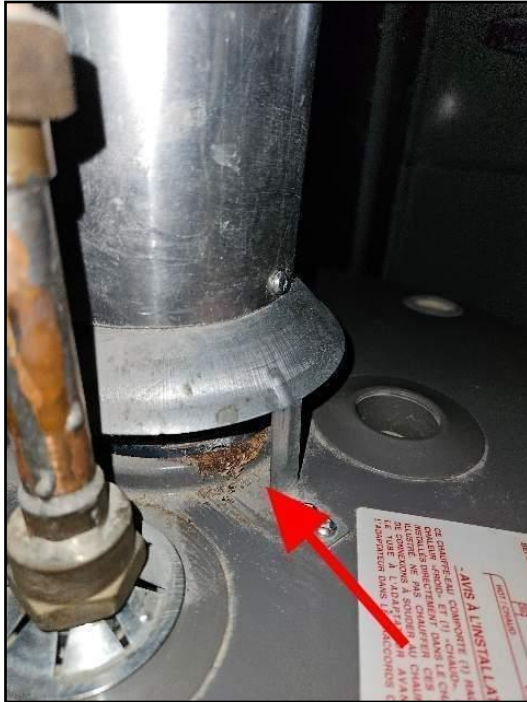
63. Rust

27. Condition: • Rust

Rust observed on the upper portion of the hot water tank near the combustion vent and vent pipe connection.

Task: Recommend further evaluation by a licensed plumber or HVAC technician to assess for potential venting issues or moisture intrusion and perform necessary repairs or maintenance.
