YOUR INSPECTION REPORT

Kevin Gable

Prairie Peaks Property Inspections O/A Carson Dunlop
0
Airdrie, AB T4B3X1

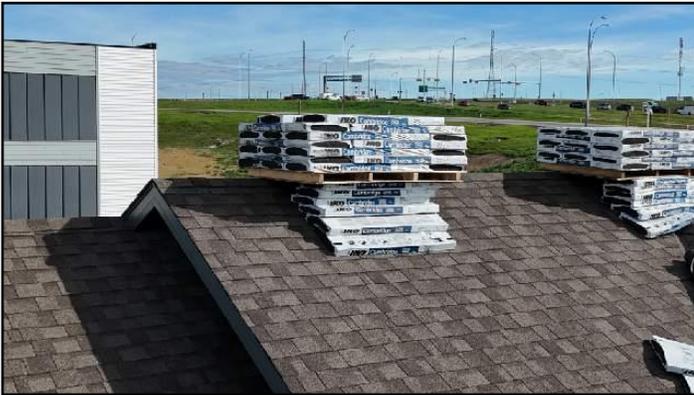
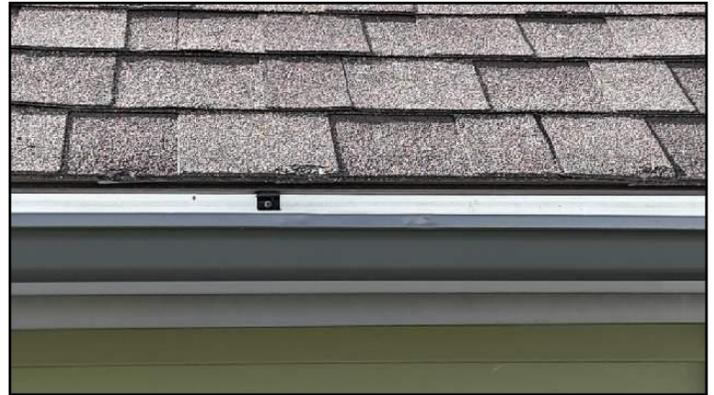
Damaged shingles visible and are in need of replacement. New asphalt shingles are located on the roof ready for installing.

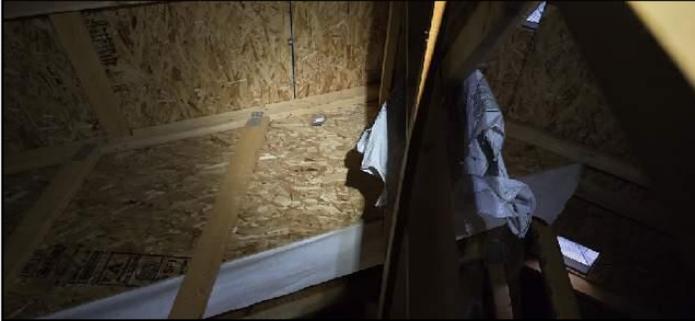
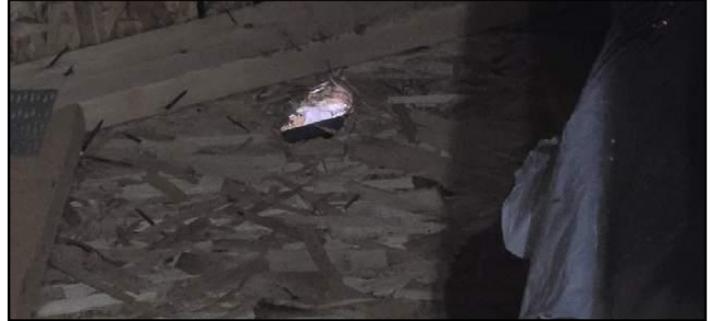
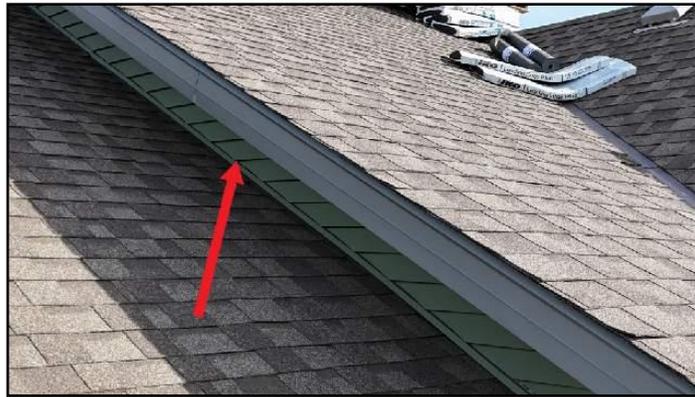
1. **Condition:** • There is a hole in the sheathing that is visible from the interior attic space. This kind of hole can leave access for birds or rodents to access the attic. Recommend having it repaired.

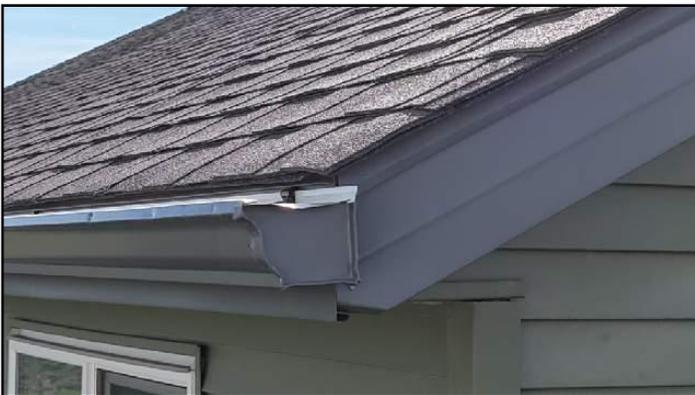
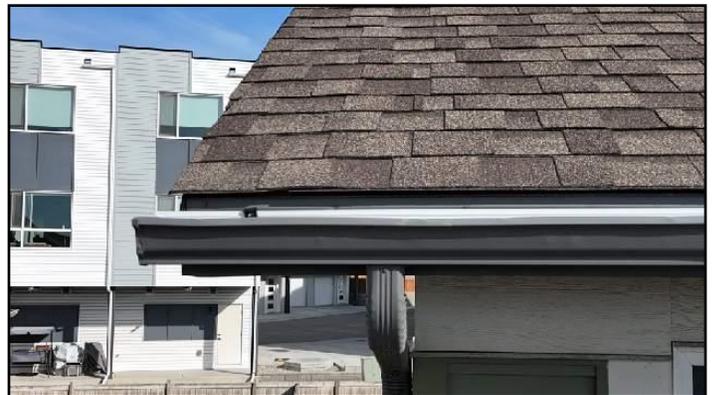
2. **Condition:** • [Too short](#)

Drip edge flashing is an important part of the roofing system. Making sure it's properly installed when the new roofing is constructed is recommended.

Implication(s): Chance of water damage to structure, finishes and contents

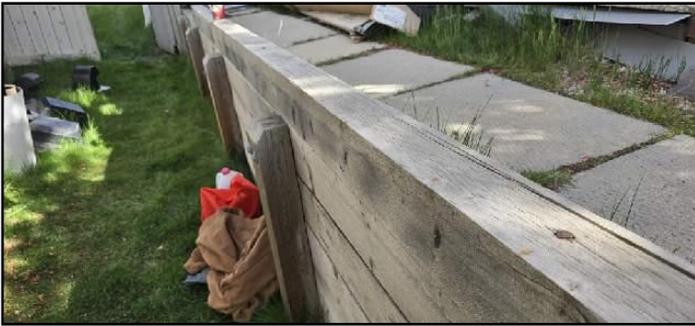
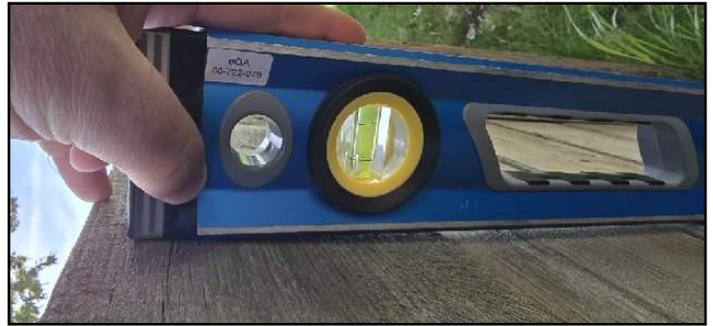
Retaining wall is leaning. It is showing approximately 1.5 inches over a 2 foot span out of alignment. It does not look like it is need of repair at this time. Recommend finding out who is responsible for any future repairs of the wall in the future.

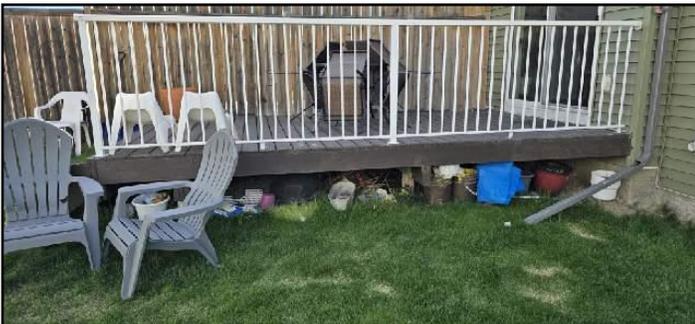
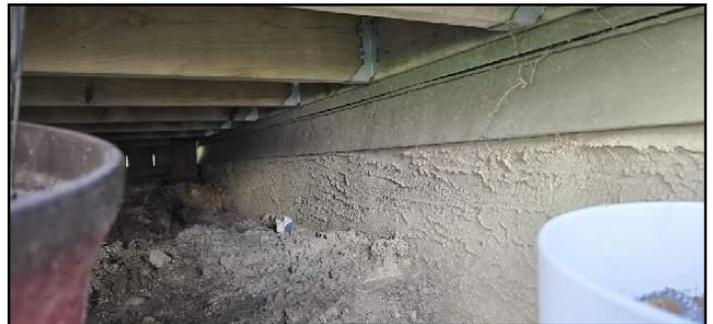
Deck is stable and secure. To help maintain the long-term life of the wood I recommend repainting it as some of the paint has been removed.

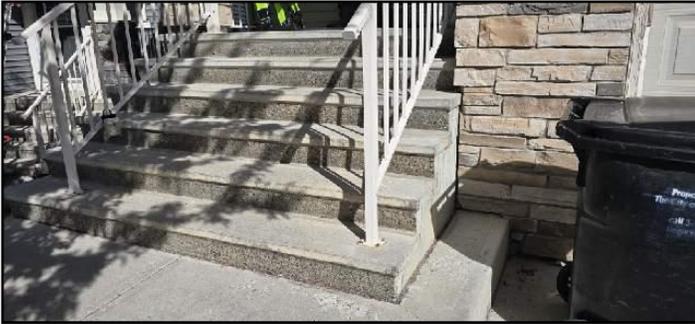
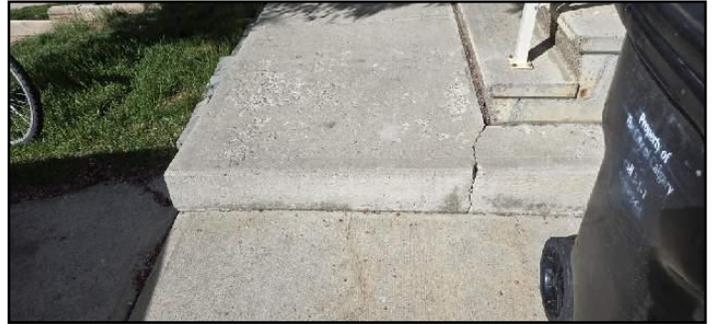
Steps are solid and the railings are sturdy. A separation crack is forming due to ground settlement. Recommend contacting a concrete company about methods of stabilizing the stairs.

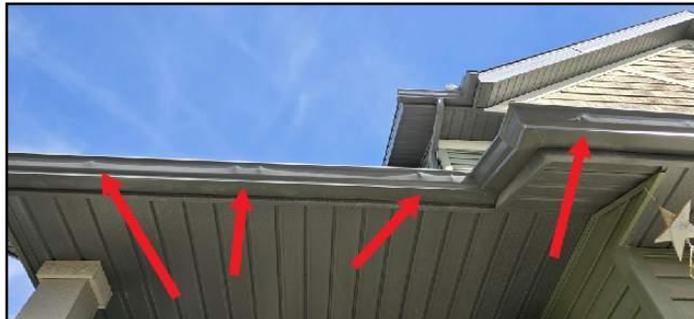
3. Condition: • Damage

Recommend replacement of the gutters.

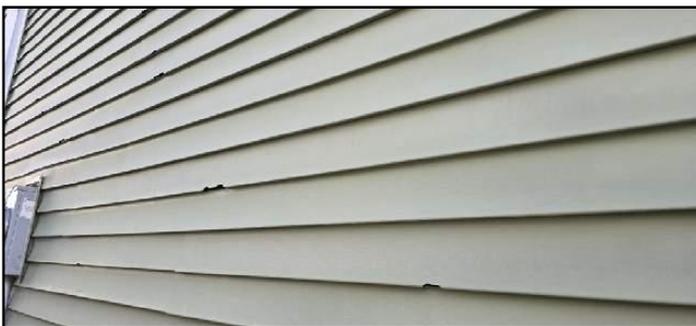
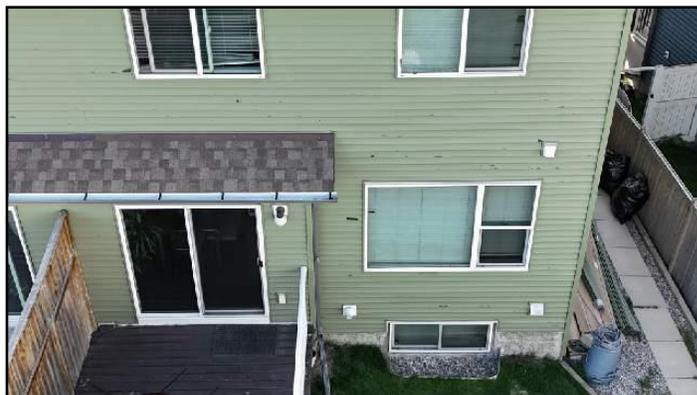
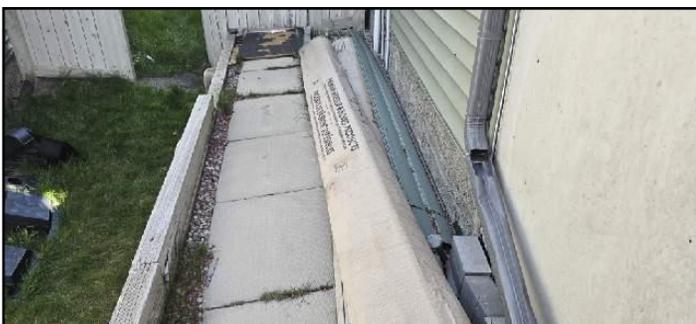
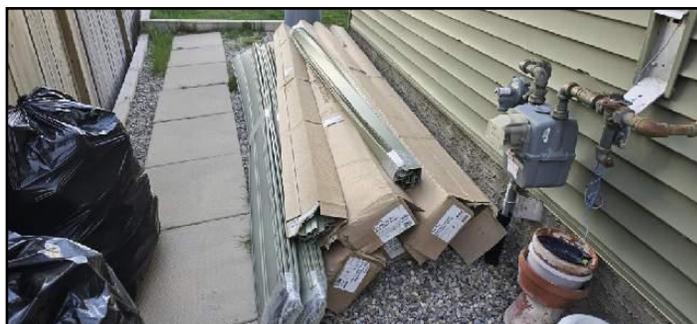
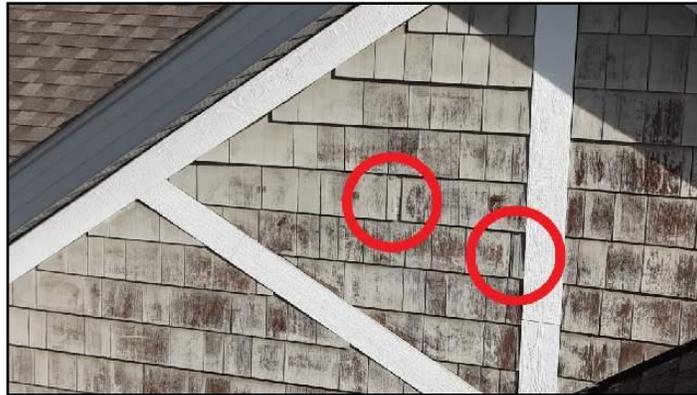
4. Condition: • [Mechanical damage](#)

Vinyl siding is damaged, but new siding is on site ready to be installed. Recommend this gets done.

Implication(s): Chance of water damage to structure, finishes and contents

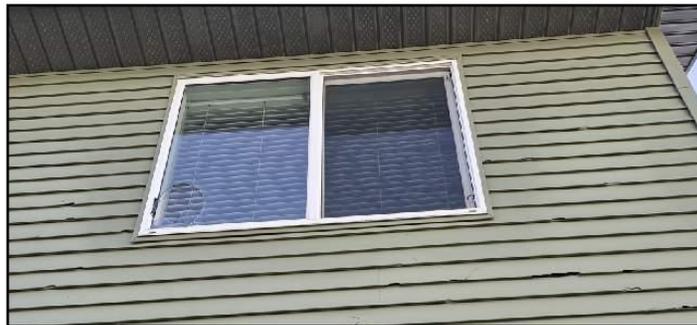
5. Condition: • Damage

Glass in the window is broken. Recommend it gets replaced with a new one.

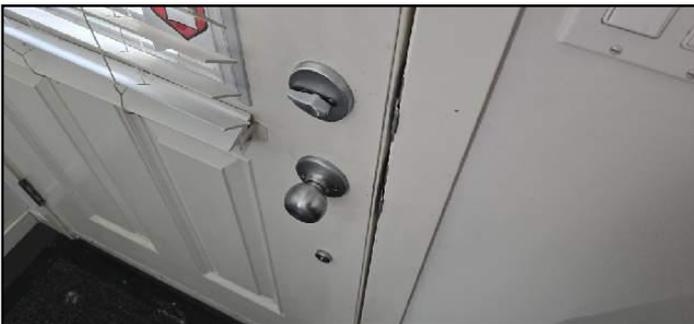
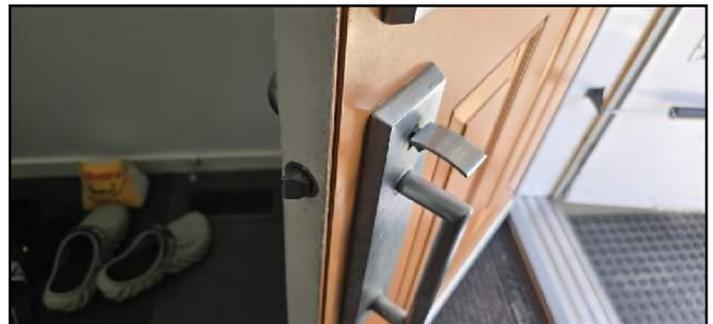
6. Condition: • Front door handle doesn't operate properly. The latch doesn't fully retract when operating the handle.

Recommend having a locksmith inspect and repair or replace the handle.

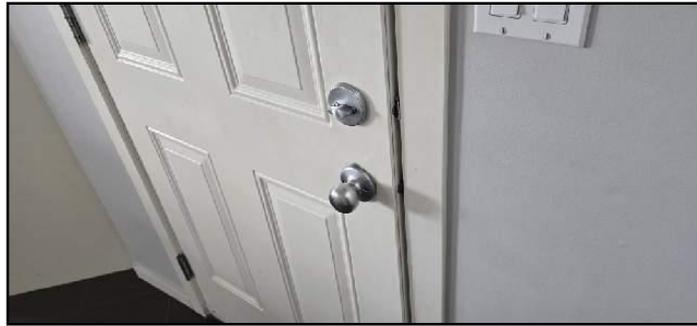
7. Condition: • [Does not close fully](#)

Garage man door does not fully close on its own. The self closing hinges need to be adjusted or replaced to prevent any off gasses from entering the home. Recommend repair or replacement of the hinges.

Implication(s): Hazardous combustion products entering home

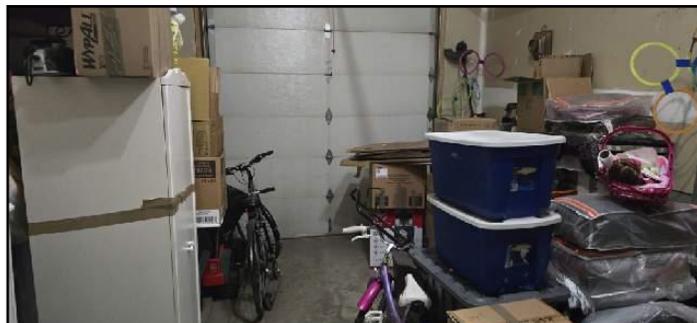
8. Condition: • [Fails to auto reverse](#)

Garage door pressure sensor does not work. Recommend repair of this safety feature.

Implication(s): Physical injury

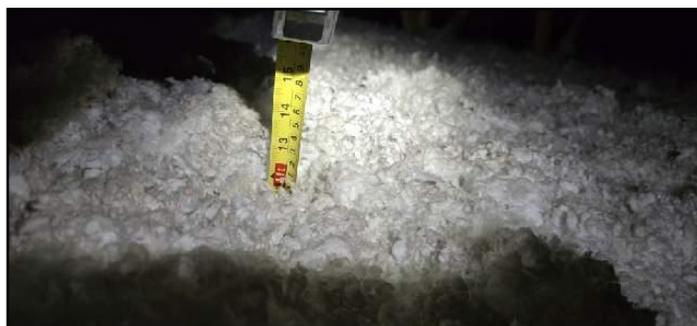
- 13 inches

Modern standards are between 12-16 inches. So this is a good amount but an area that can be improved for thermal efficiency.

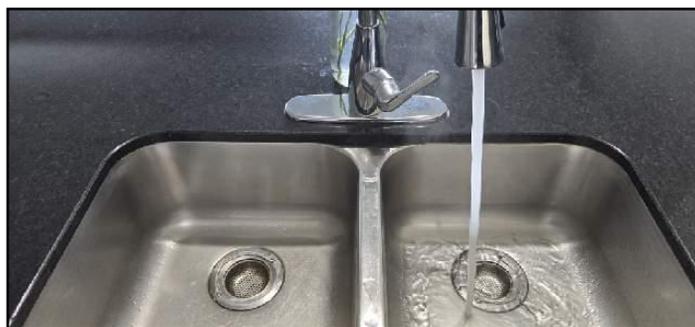
9. Condition: • [Loose](#)

Implication(s): Equipment failure

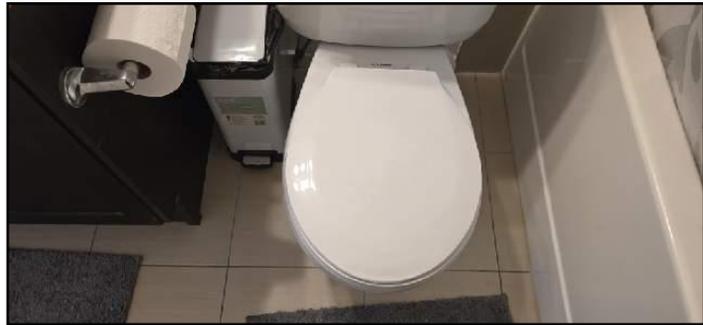
10. Condition: • [Loose](#)

Toilet moves side to side easily which can cause leaks. Recommend having this corrected.

Implication(s): Chance of water damage to structure, finishes and contents | Sewage entering the building | Possible hidden damage

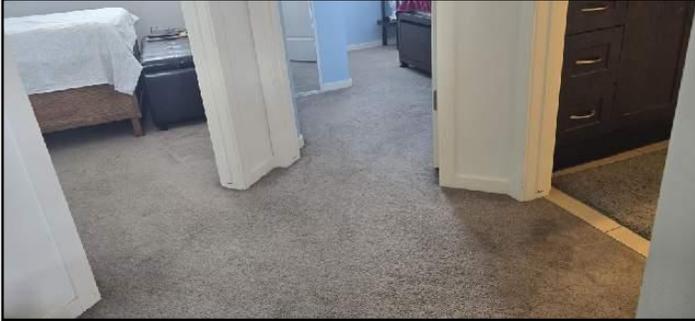
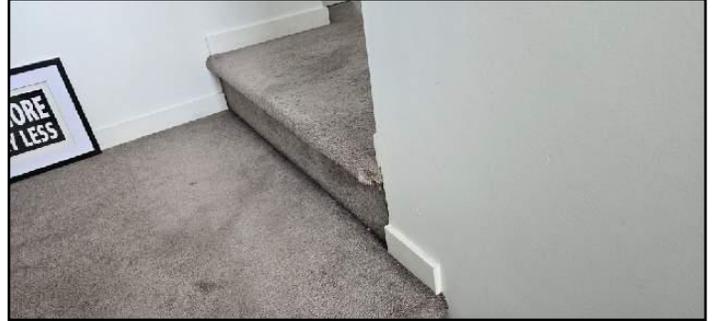
I inspected the flooring for wrinkles or worn-out sections. Only one small defect found on the stairs.
