INSPECTION REPORT

[REDACTED]
Calgary, AB T2Z 0S5

INSPECTION DATE

Monday, September 22, 2025

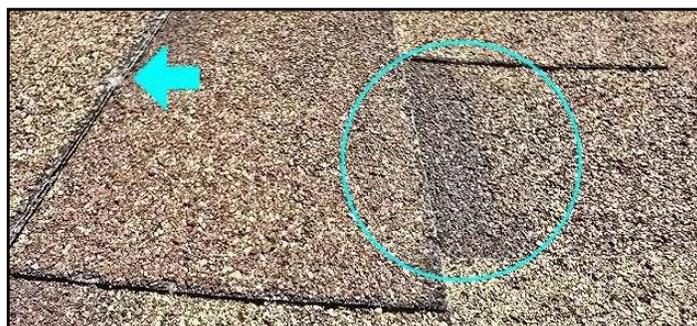
8. Near end of life expectancy

1. Condition: • [Near end of life expectancy](#)

Near end of life means that the materials are at or past 80% of their intended life span, and you should budget for replacement. I recommend speaking with a roofing company to get an estimate to help plan for the future.

Implication(s): Chance of water damage to structure, finishes and contents

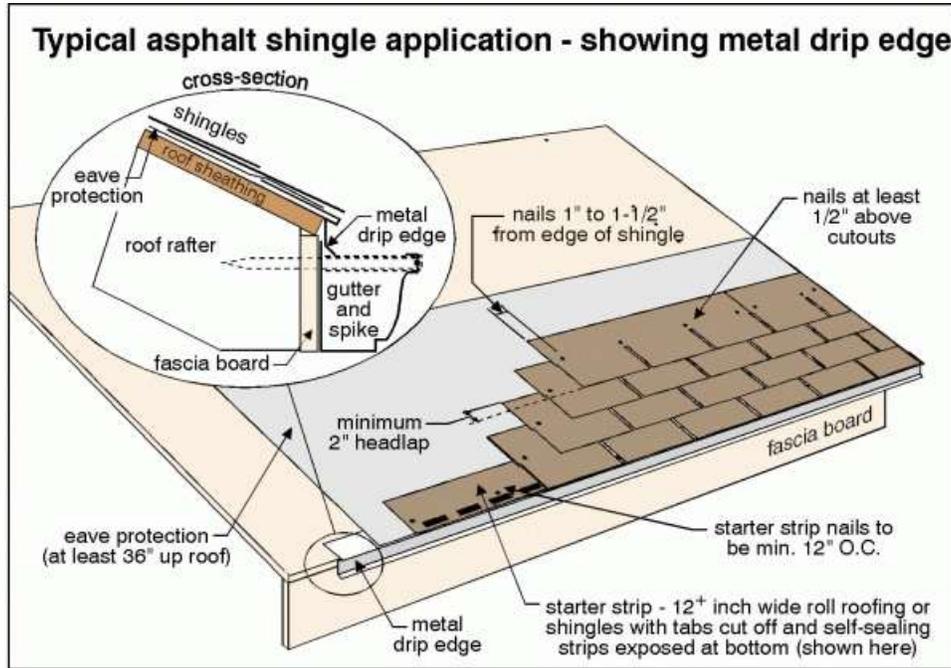
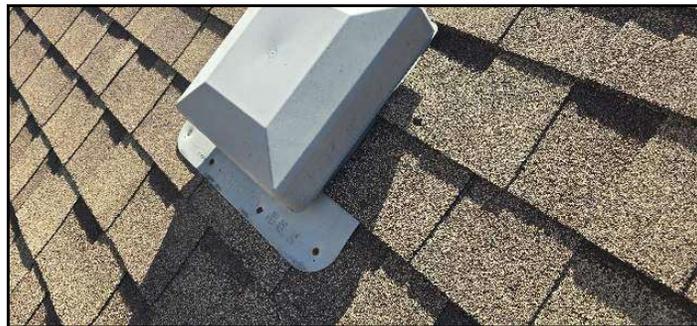
9. Exposed fasteners

2. Condition: • [Exposed fasteners](#)

Implication(s): Chance of water damage to structure, finishes and contents

All exposed fasteners should be caulked/sealed to prevent the potential for moisture intrusion.

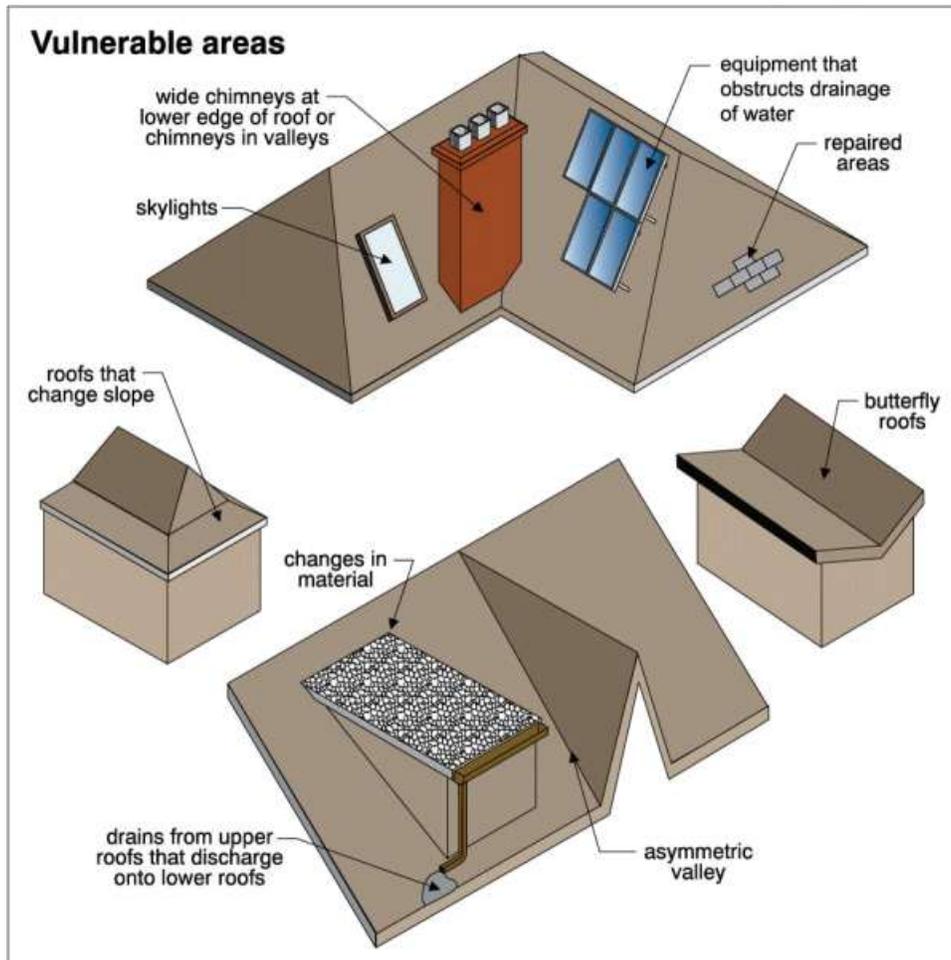
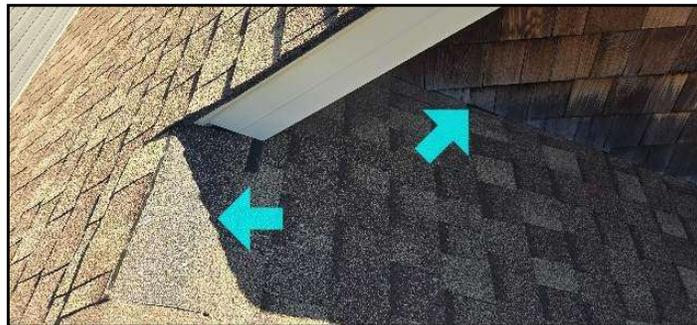
10. Vulnerable areas

3. Condition: • [Vulnerable areas](#)

This shingle is not installed correctly on the capping and the siding is not cut properly along the edge of the roof. There should be a gap between the roof and siding to prevent damage to the siding. Recommend having a roofing company come and repair.

Implication(s): Chance of water damage to structure, finishes and contents

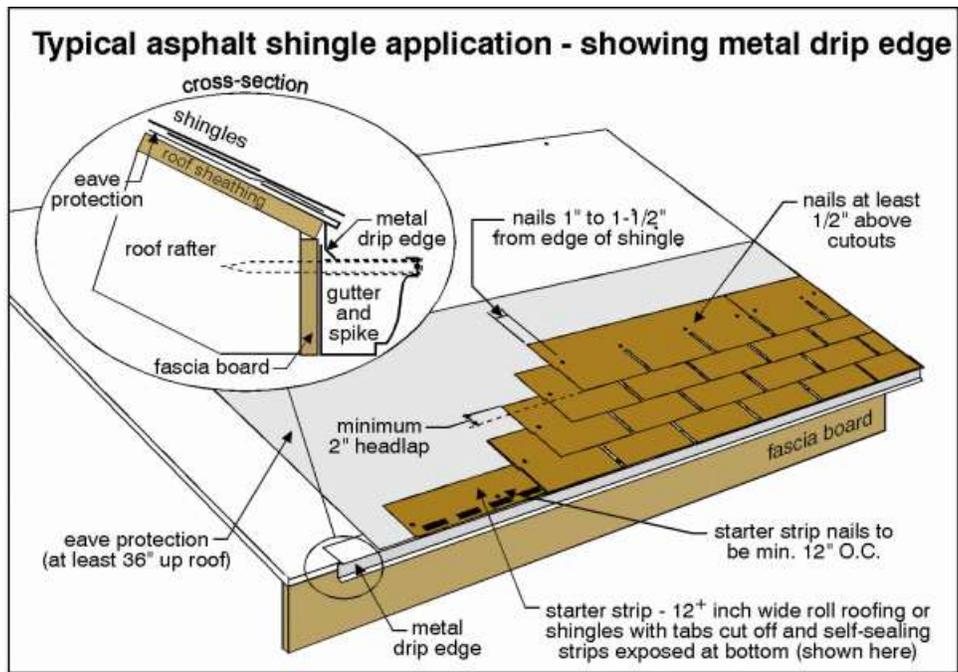
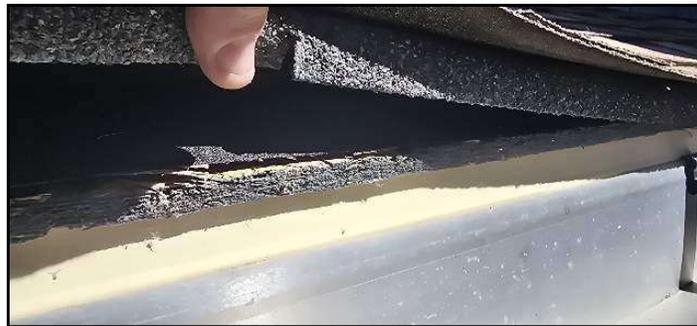
11. Missing

4. Condition: • [Missing](#)

Implication(s): Chance of water damage to structure, finishes and contents

I recommend having drip edge flashing installed as a way to help protect the roof sheathing.

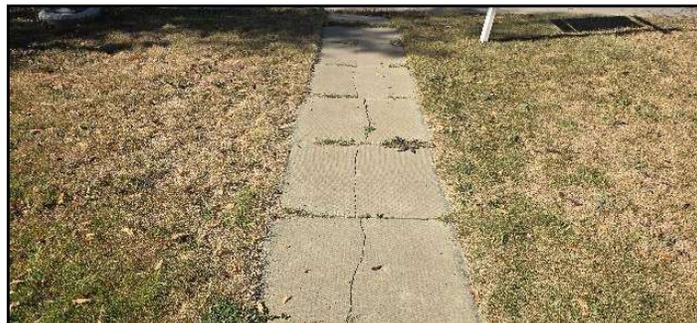
14. *Pavers*

The pavers are cracked but they do not appear to be a safety or tripping hazard at this point. Recommend monitoring and replacement as needed.

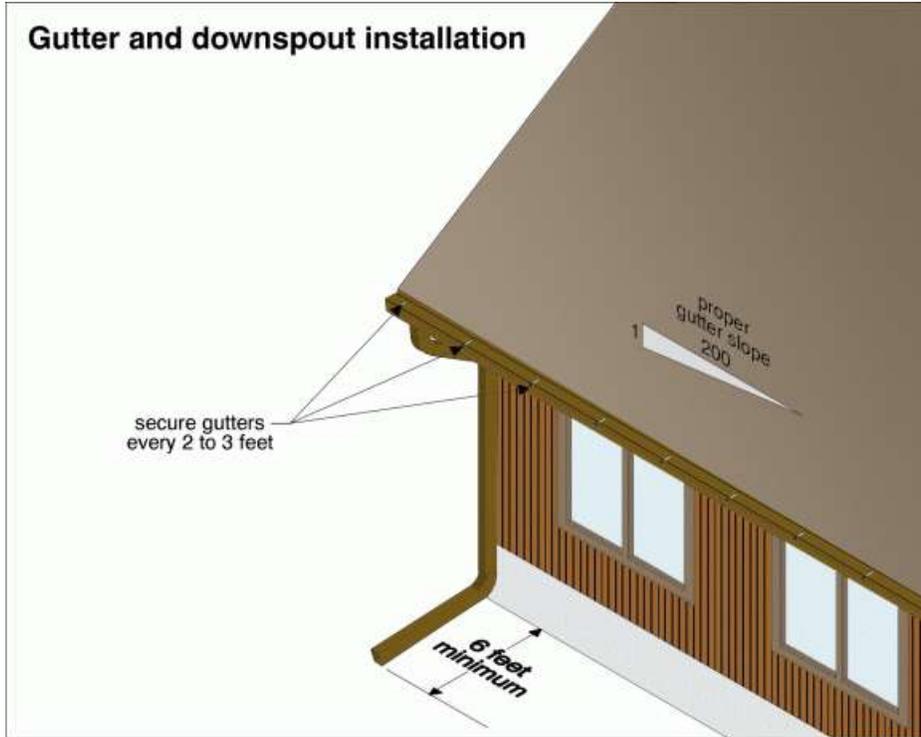
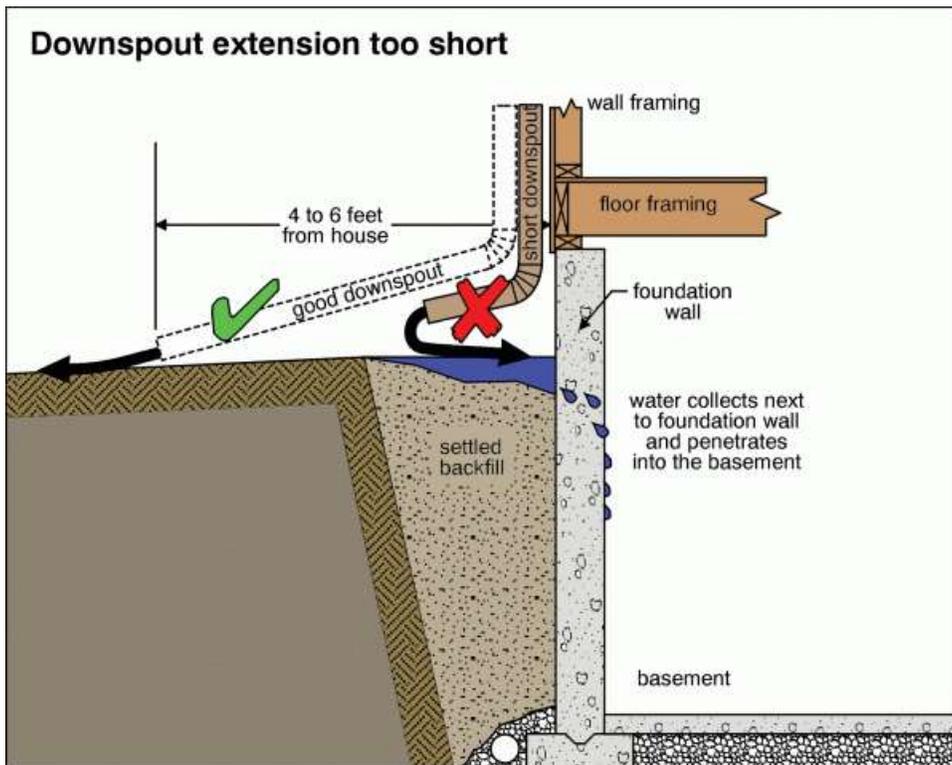
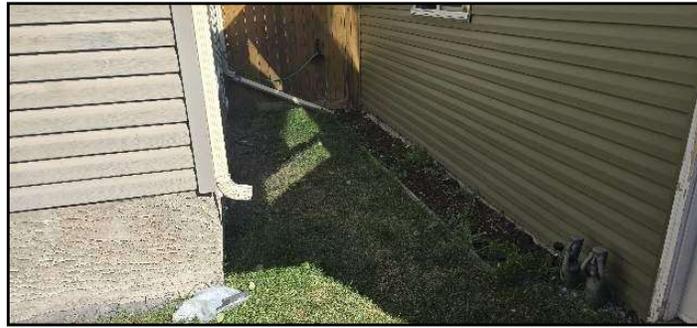
22. Should discharge 6 feet from building

5. Condition: • [Should discharge 6 feet from building](#)

Implication(s): Chance of water damage to structure, finishes and contents

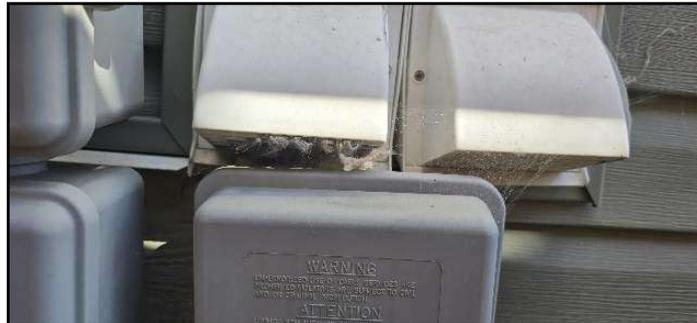
23.

6. Condition: • There is very little space between the dryer vent and the communication box below. I recommend having this corrected to prevent clogs or exhaust issues.

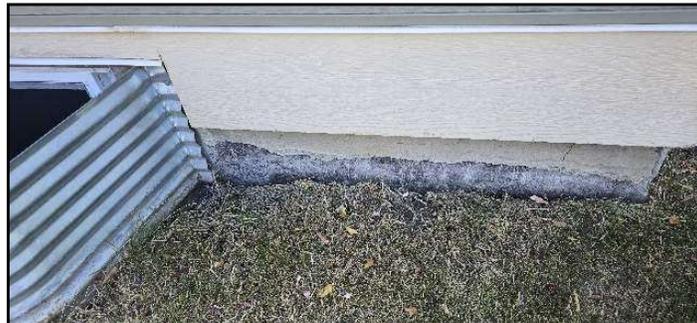
28. Parging damaged or missing

7. Condition: • [Parging damaged or missing](#)

Implication(s): Chance of damage to structure | Shortened life expectancy of material

Recommend having the parging repaired to ensure the foundation is protected from potential moisture damage.

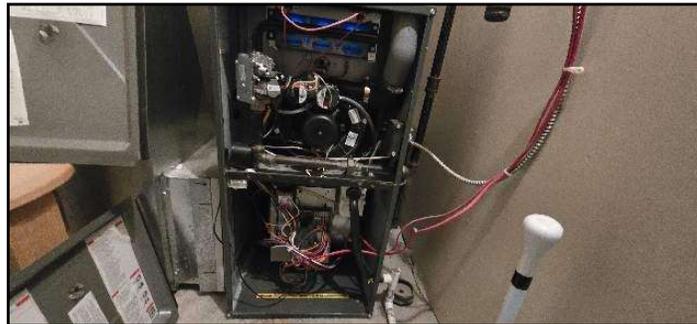
54. Service Furnace

8. Condition: • Service Furnace

Recommend the ductwork for the dryer and furnace get cleaned and serviced by a professional technician. The furnace safety switch for the lower cabinet area is not functioning. This should also be repaired.

I did notice what appeared to be dirt/water stains around one of the duct connections in the utility room. The technician should inspect for a potential cause and repair.

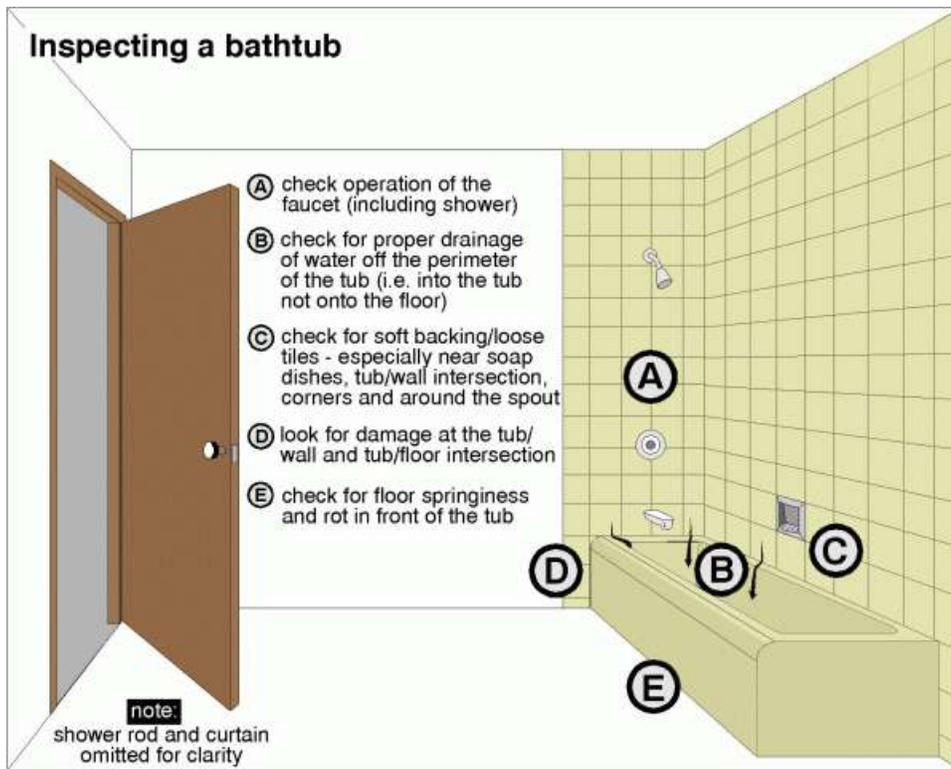
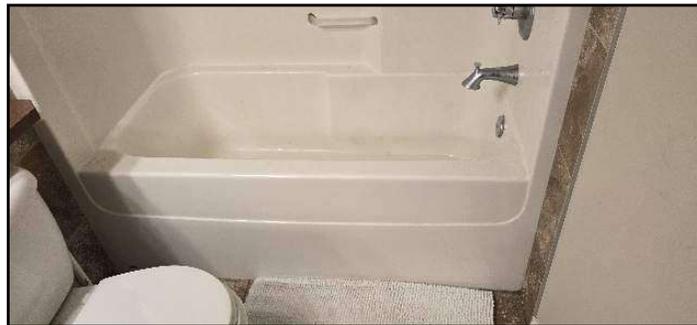
75. Slow drain

9. Condition: • [Slow drain](#)

Basement bathtub drains slow. Recommend having a plumber come and inspect/repair.

Implication(s): Chance of water damage to structure, finishes and contents

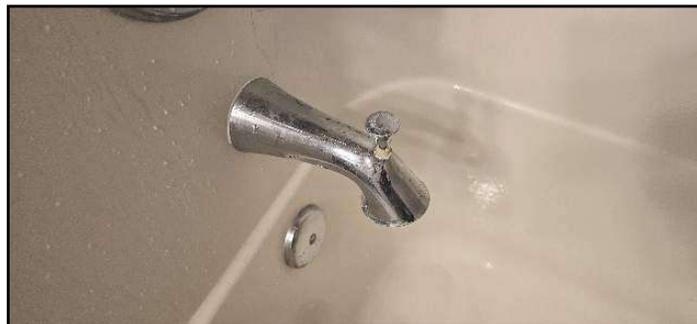
76. Loose or unstable

10. Condition: • [Loose or unstable](#)

Implication(s): Chance of water damage to structure, finishes and contents

Recommend securing and sealing the bathroom fixtures to prevent moisture damage.

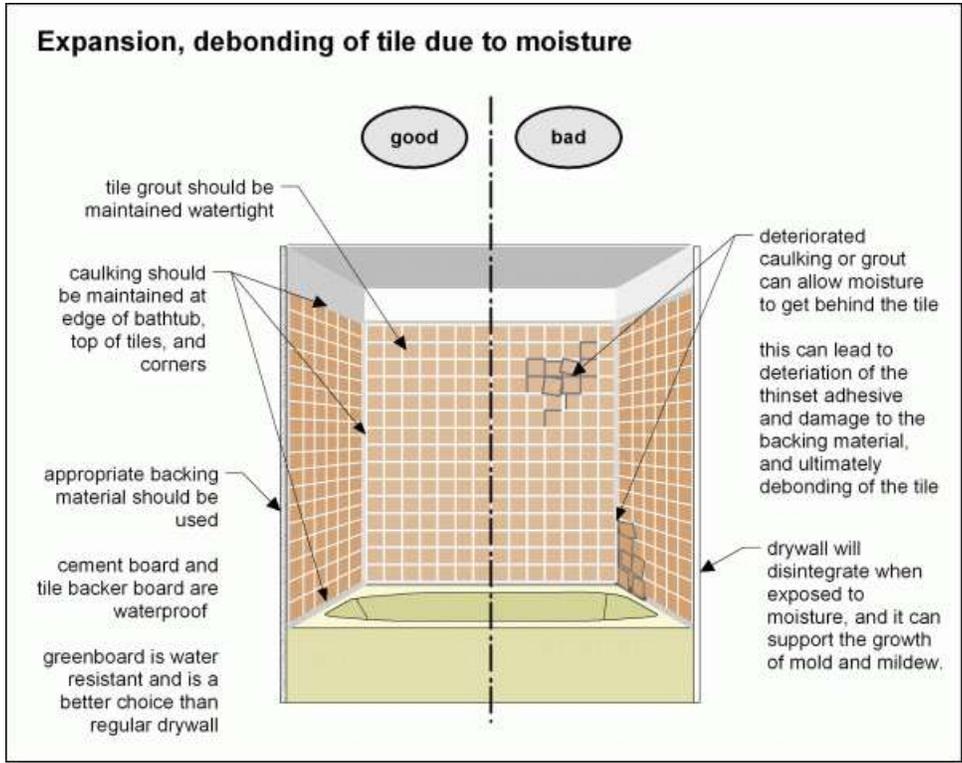
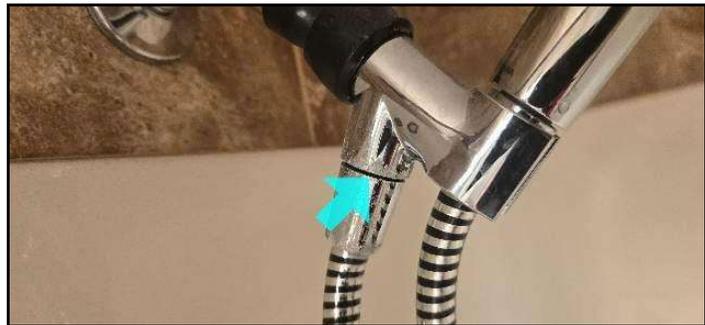
77. Leak

11. Condition: • [Leak](#)

The shower head connection is leaking. Recommend monitoring and having it repaired as needed.

Implication(s): Chance of water damage to structure, finishes and contents

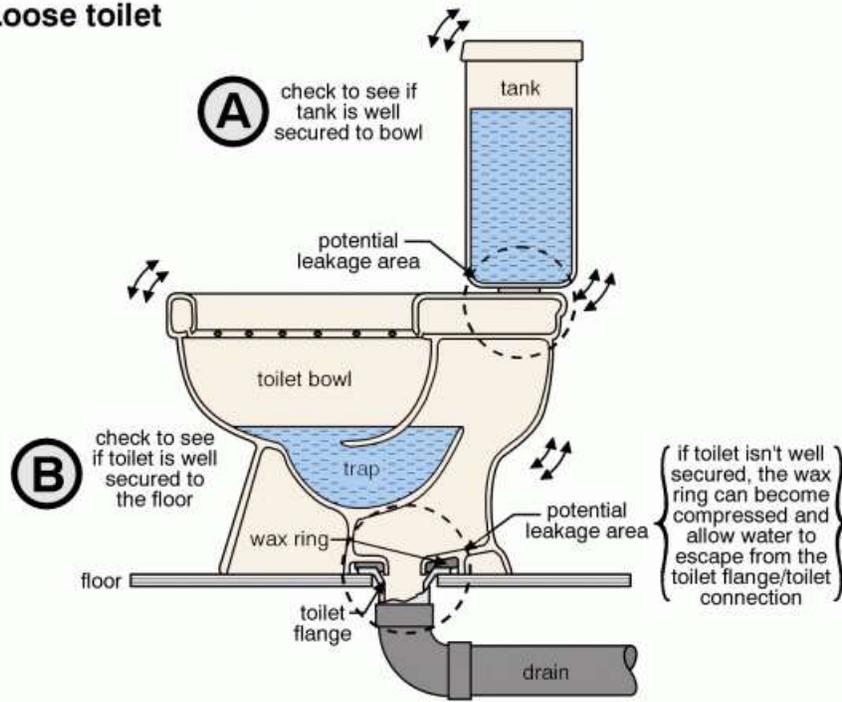
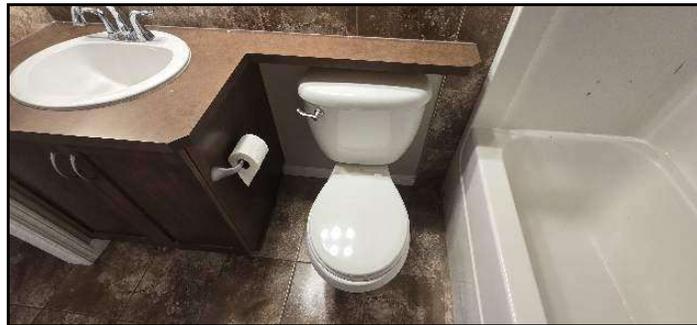
78. Loose

12. Condition: • [Loose](#)

Implication(s): Chance of water damage to structure, finishes and contents | Sewage entering the building | Possible hidden damage

Loose toilet

Recommend having the toilet secured to prevent the potential for a leak.

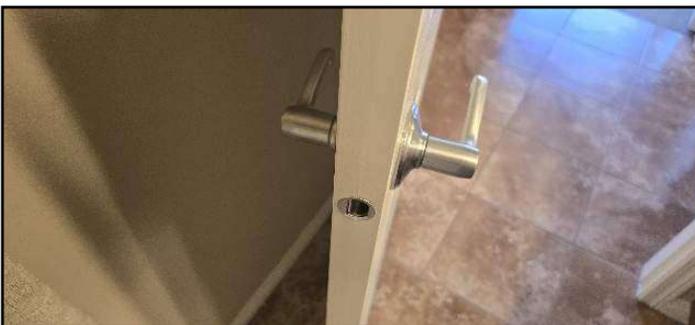
100. Broken

DOORS \ Hardware**13. Condition:** • [Broken](#)

The main floor bathroom and basement bathroom handles are either not securing or locking. Recommend having both bathroom door handles repaired or replaced for added privacy and comfort.

Implication(s): System inoperative or difficult to operate
