## PRECISION INSPECTION SERVICES

123 Road

Rocky Mountain House, Alberta T4T 2A3

08/13/2026

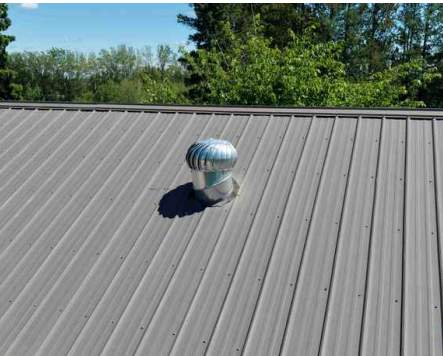
There is a metal turbine vent on the southwest side of the roof. The vent was functioning properly at the time of the inspection.

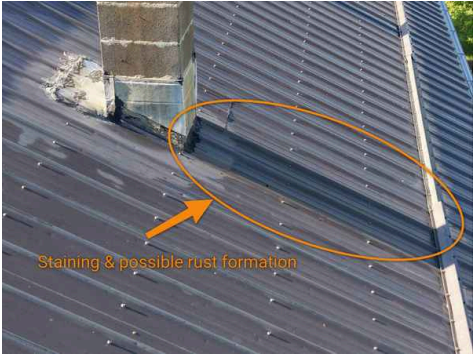
2.1.1 Roof Coverings

WORN PAINT AND RUST ON METAL ROOF

Paint coating on the metal roof shows minor wear with visible staining and possible rust formation. Deteriorating paint protection can allow moisture penetration and accelerate corrosion of the underlying metal. A roofing professional should evaluate the extent of rust development and recommend appropriate treatment or coating restoration to prevent further deterioration.

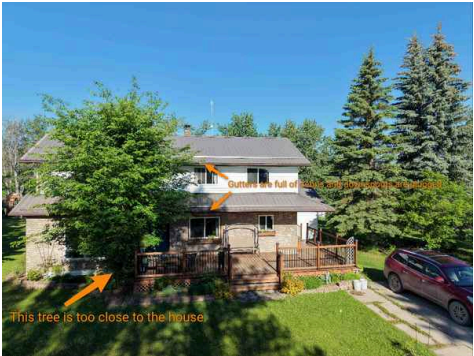
2.3.1 Roof Gutters & Downspouts

DEBRIS

Debris has accumulated in the gutters. Also, there is a tree located too close to the house. The tree branches are touching the roof and the leaves are plugging up the gutters. Recommend removing the tree on the east side of the house and cleaning to facilitate water flow.

Contact a qualified gutter contractor

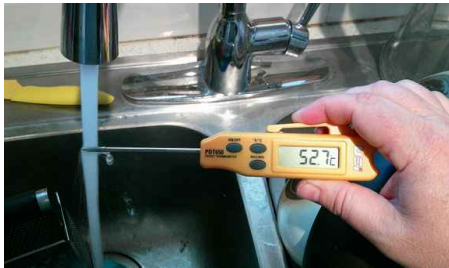
Water temperature was set at 53 °C this is within the recommended water temperature of 49 °C to 60 °C.

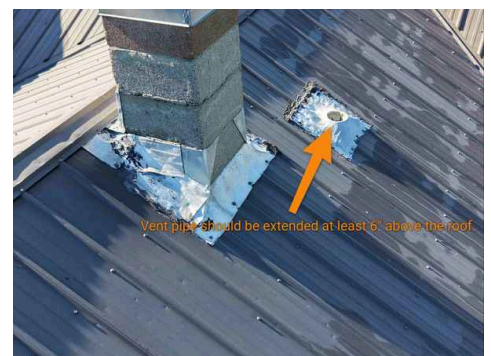
### 6.3.1 Drain, Waste, & Vent Systems

#### SEWER VENT INSUFFICIENT HEIGHT

One of the sewer vent pipes terminating through the roof is too short to meet proper drainage standards. Vent pipes must extend a minimum distance of 6"-12" above the roof surface to allow gases to disperse safely and prevent water from backing up into the drainage system. A plumbing contractor should evaluate the vent height and extend it to the required specification.

Contact a qualified plumbing contractor.

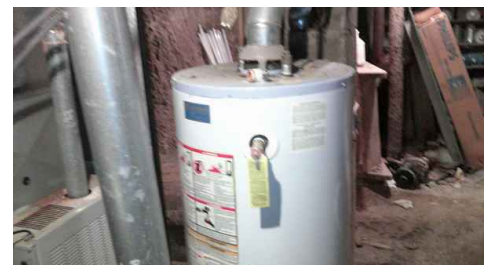
### 6.5.1 Water Heating Equipment

#### NEAR END OF LIFE

Water heater showed normal signs of wear and tear.

Typically, manufacturers recommend replacement at 12 - 15 years. This water heater is approximately 19 years old. It was functioning properly at the time of the inspection.

Recommend monitoring it's effectiveness and operation.

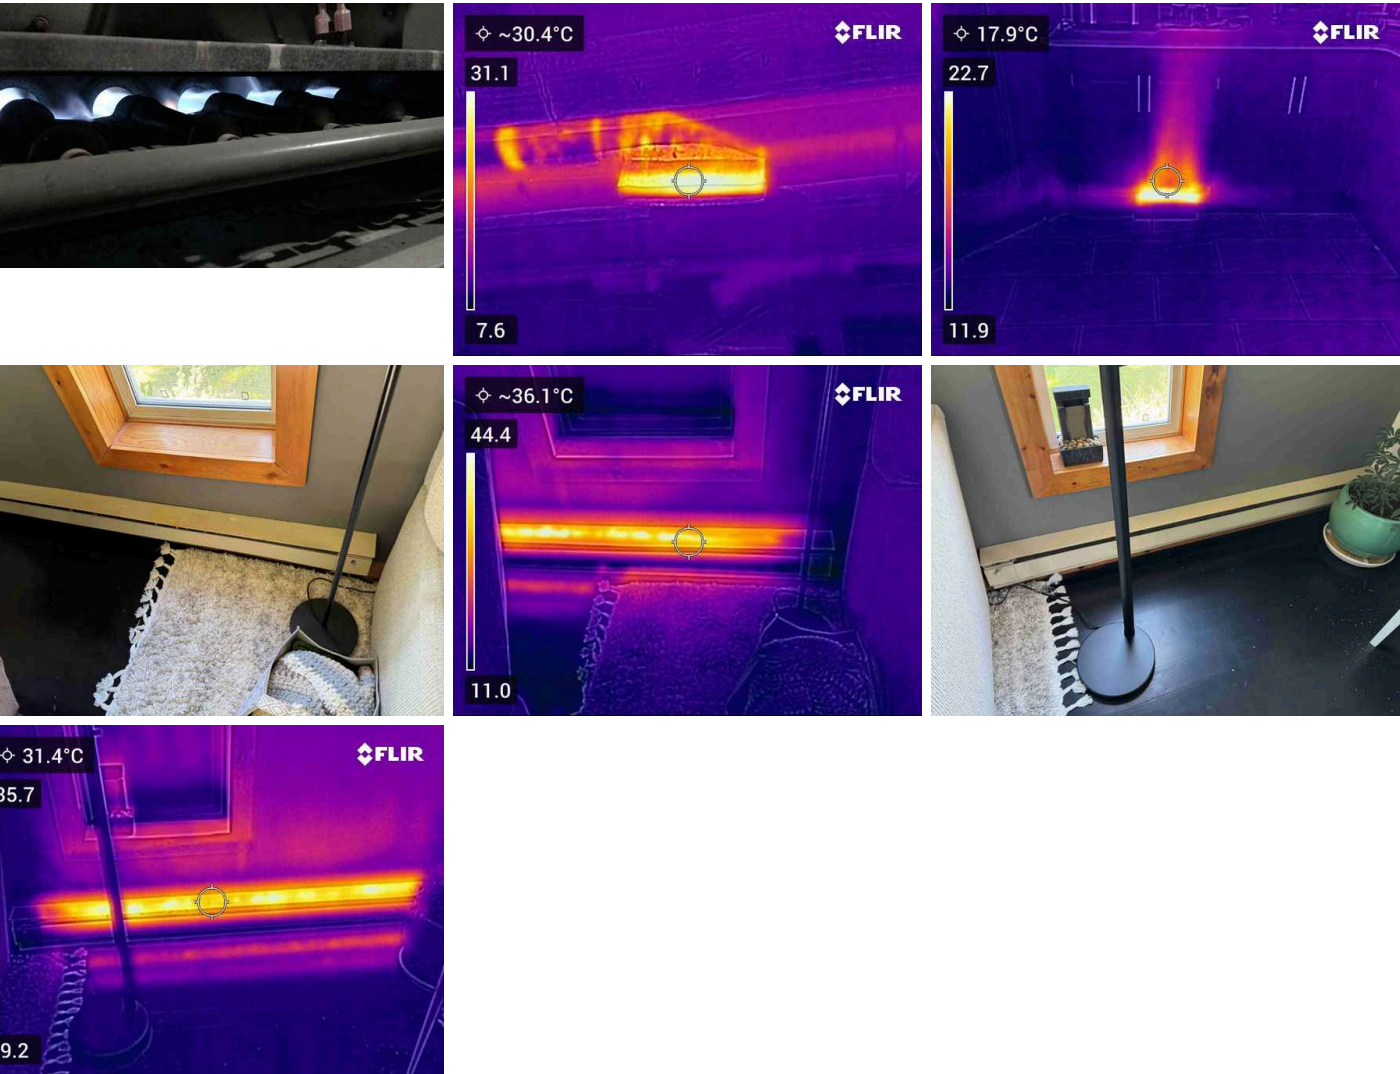
Furnace was running properly at time of inspection. Some signs of rust were noted within the unit. Heat distribution was acceptable with no problems to report. It is important that the furnace be properly maintained for efficiency and greater life span. Recommend a yearly maintenance program be set up with a local heating company to service and clean the furnace. This could greatly improve the life span of unit.
