INSPECTION DATE
Saturday, October 25, 2025

INSPECTED BY
Scott Watson

The Carson Dunlop - Watson Team
4066 Huron Church Line Rd
LaSalle, ON N9H1G8

RE: Report No. 1012, v.3

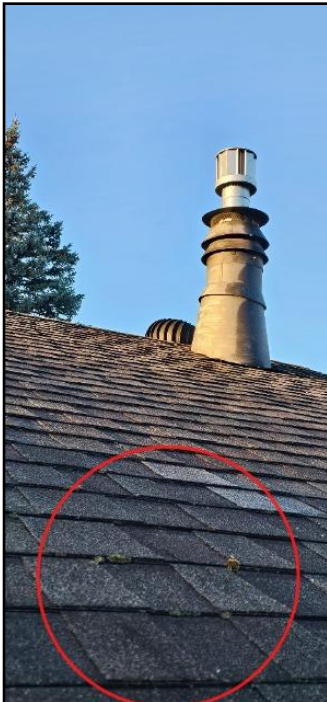
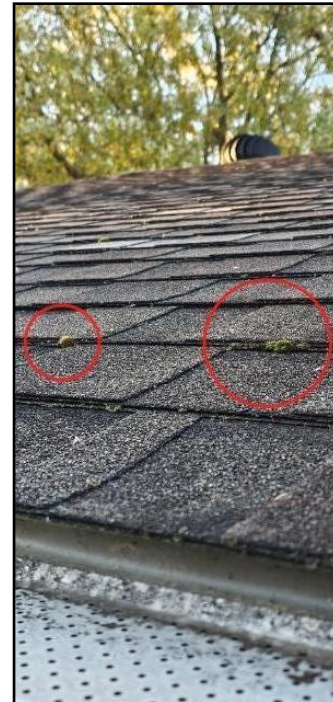
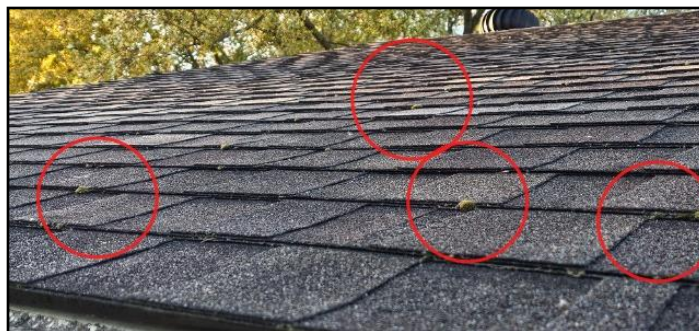
1. Condition: • Debris/moss

spots of moss growing on the front roof

Implication(s): Shortened life expectancy of material

Task: Further evaluation

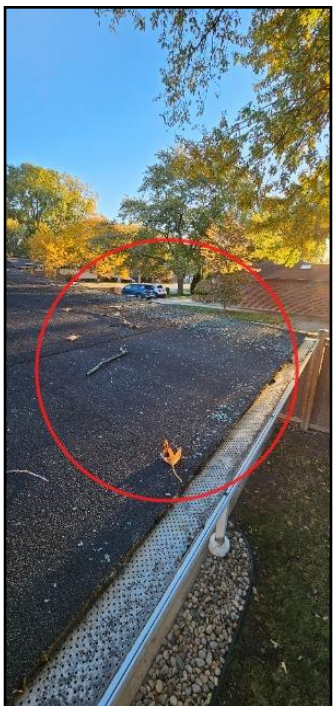
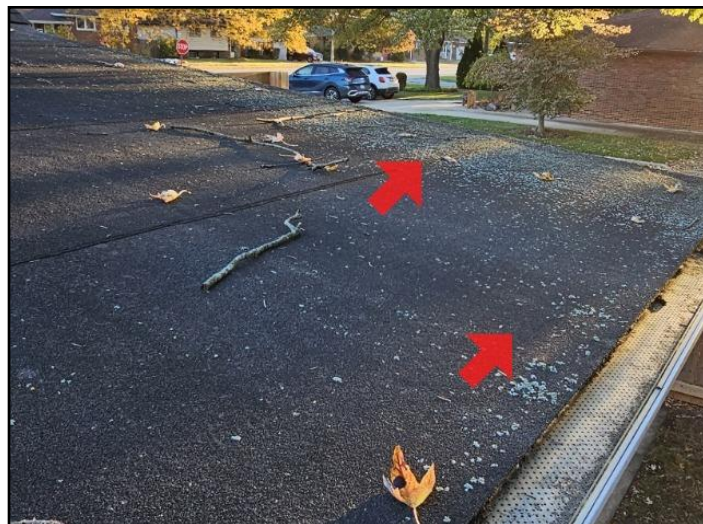
2. Condition: • [Algae discoloration](#)

Possible algae discoloration or deterioration of roofing membrane

Implication(s): Chance of water damage to structure, finishes and contents

Should be evaluated by a licensed roofer

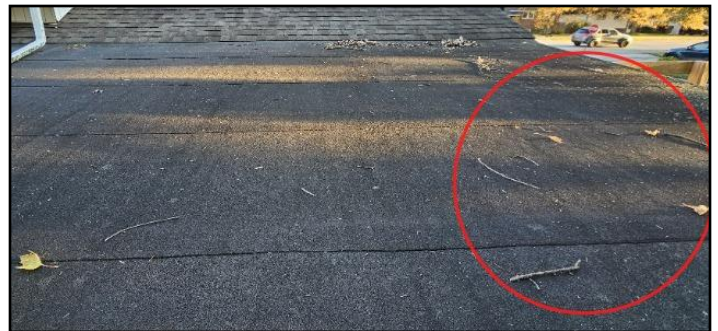
12. Tree branches touching roof

3. Condition: • [Tree branches touching roof](#)

Tree branches do not appear to be touching the roof but debris on roof is probably from the tree

Implication(s): Shortened life expectancy of material

Task: Further evaluation

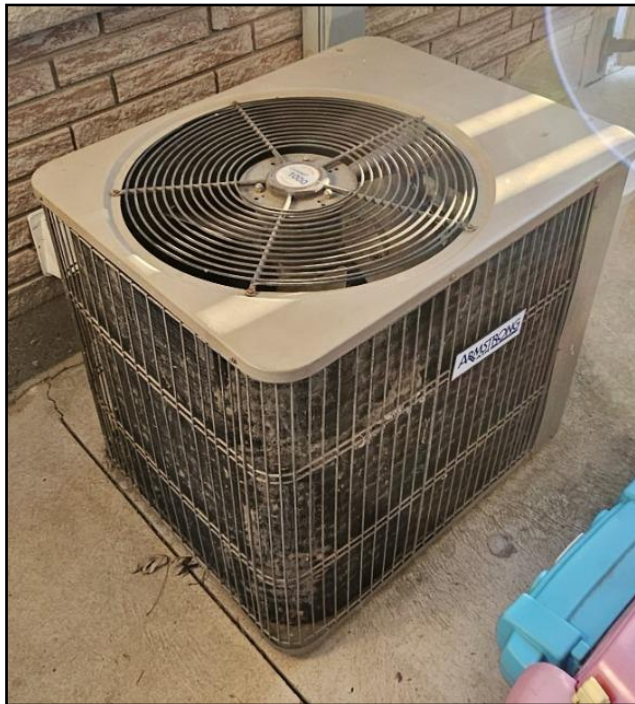
47.

9. Condition: • Needs to be clean when necessary

Task: Clean

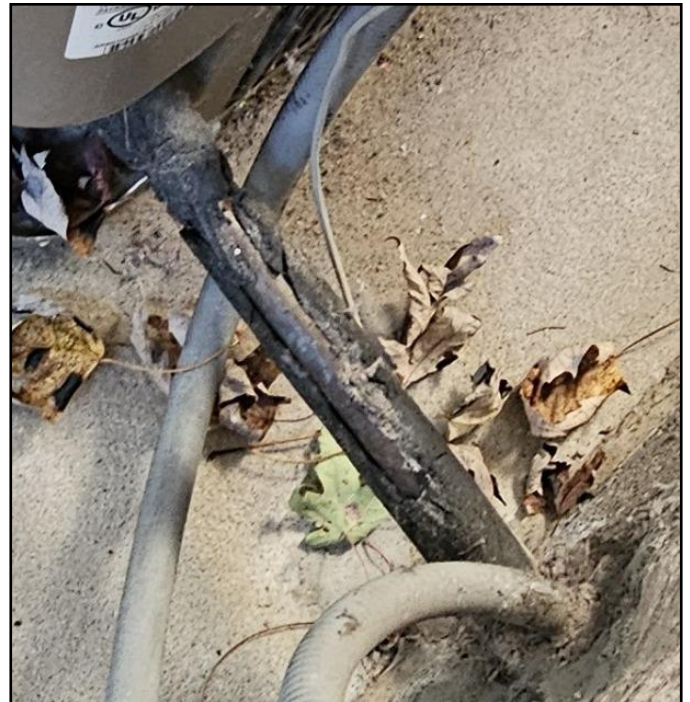
10. Condition: • [Insulation - missing](#)

Implication(s): Reduced system life expectancy | Increased cooling costs | Reduced comfort

49. Insulation - missing

Task: Repair or replace
