YOUR INSPECTION REPORT

Kevin Gable

Prairie Peaks Property Inspections

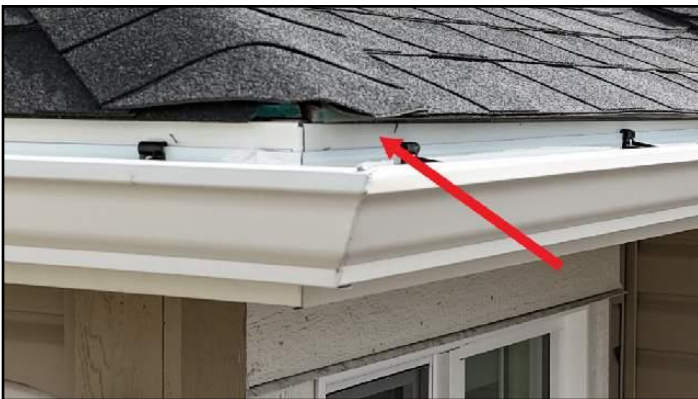
1. Condition: • [Missing](#)

5. Missing

Recommend having drip edge flashing installed.

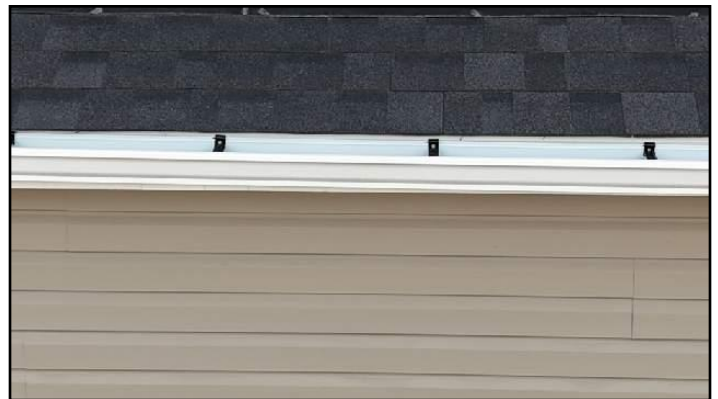
6. Missing

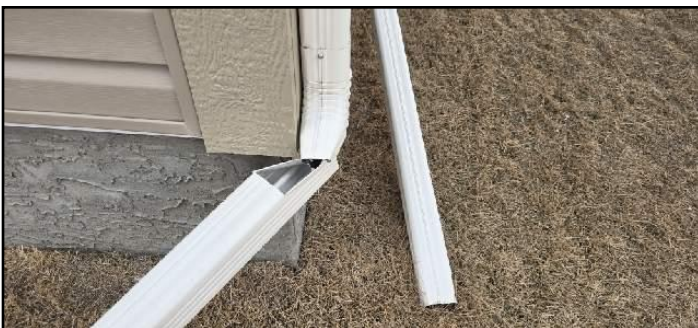
16.

2. Condition: • Recommend fixing downspout to allow for proper water flow

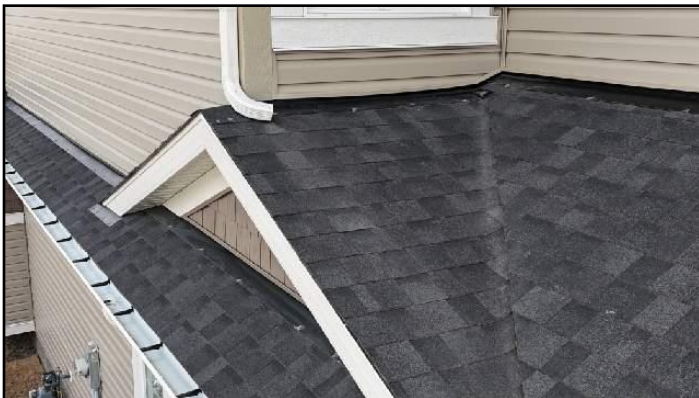
Discharge of the downspouts on to a lower roof can shorten the life of the shingles in that area do to the volume of water. It's best practice to continue the downspouts to the eaves when you can to give your roof and the shingles a longer life.

18. Discharge onto roofs

installing a downspout (from the secondary roof to the main gutter below) helps prevent localized roof wear

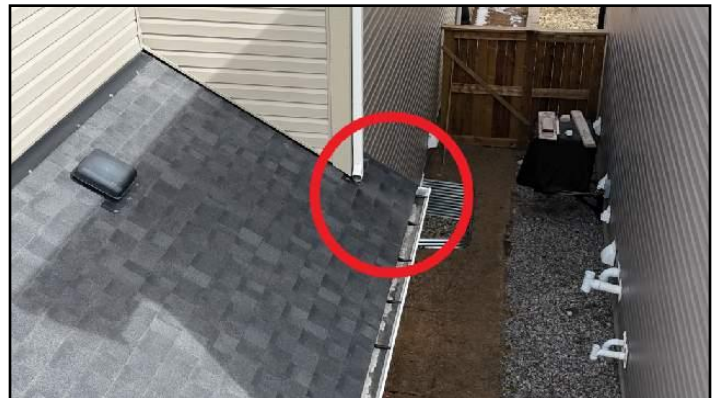
19. Discharge onto roofs

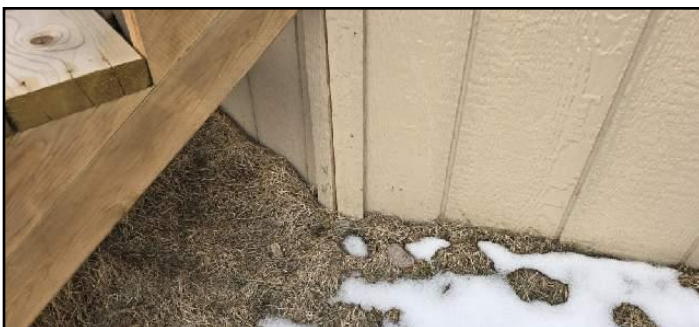
Wood in direct contact with the soil will significantly shorten the life of the wood.

20. Wood/soil contact

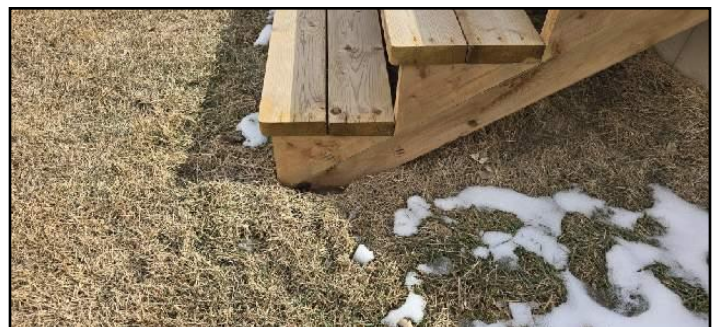
21. Wood/soil contact

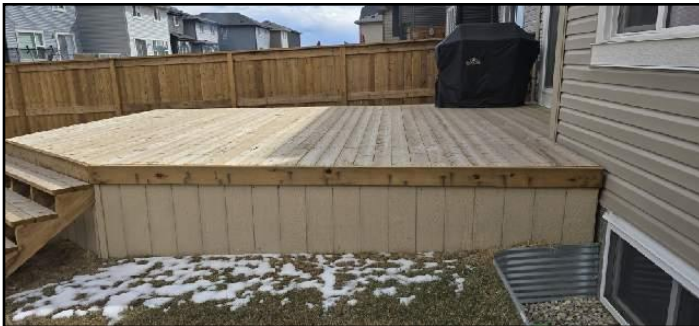
5. Condition: • Missing

22. Missing

Recommend having railing installed at the steps and around the deck for safe use.

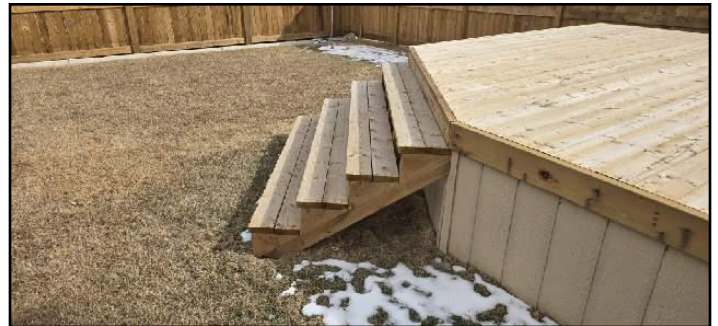
23. Missing

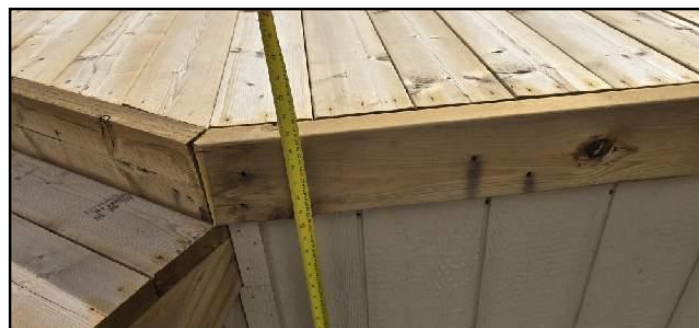
24. Missing

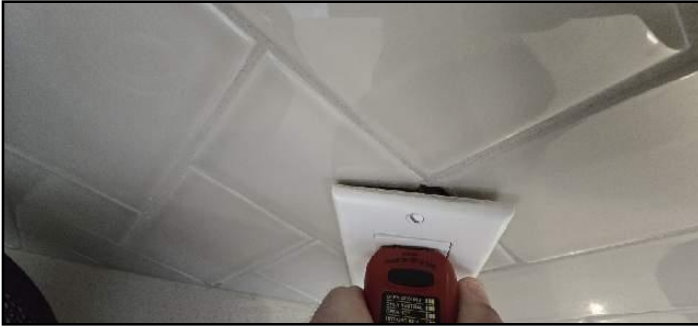
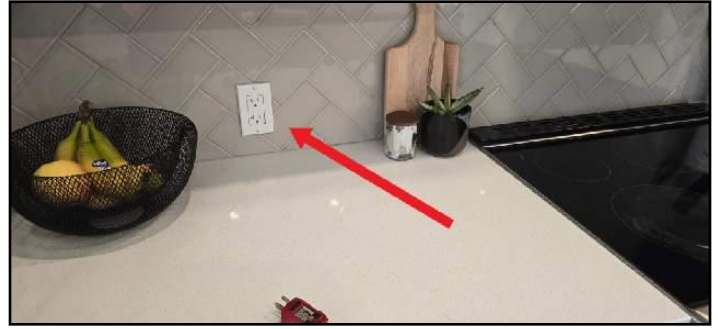
6. Condition: • This electrical outlet in the kitchen to the left of the stove is not properly secured to the wall. When someone tries to unplug something from the outlet it pulls the top of the plug from the wall. I recommend having this outlet inspected by an electrician and fixed on their recommendation.

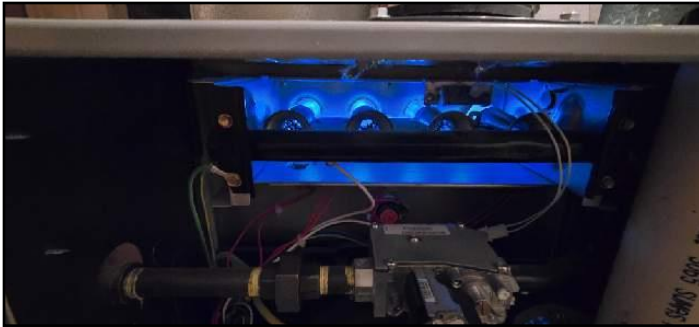
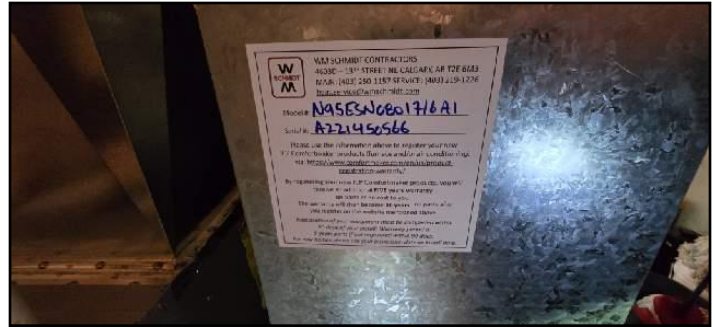
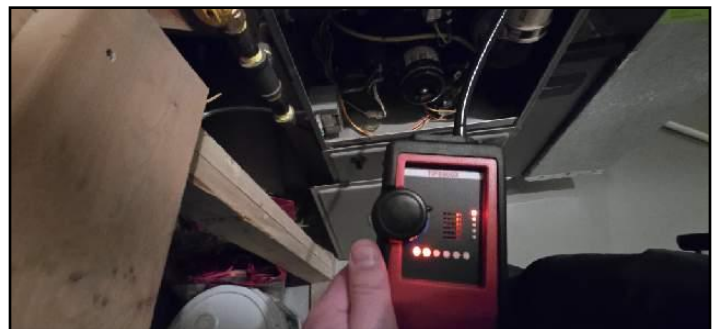
The furnace is functioning well. However when I was inspecting the furnace I could detect a small gas odor. I checked with my Tiff for signs of a gas leak and found positive readings. This can be a a common thing with high efficiency furnaces. I recommend having the furnace serviced by a professional to ensure proper functioning.

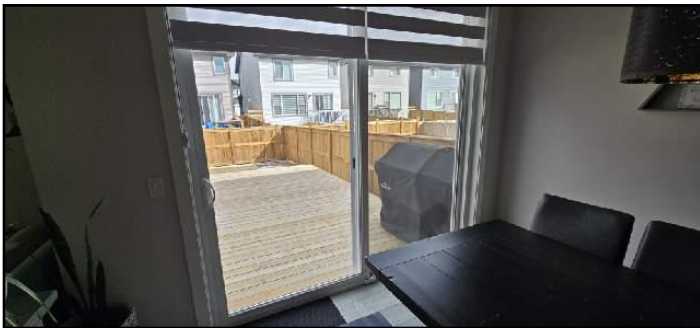
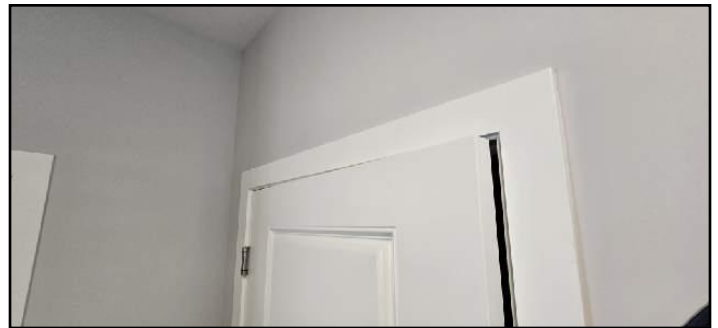
The doors in the house were all inspected including the patio door. The only fault found was the self closing function on the door to the garage from the house is not fully operational. This is a safety feature that prevents off gases from vehicles from entering the house. In this case it appears that the hinge is not quite strong enough and may need adjustment or replacement.
