TOP 10 RED FLAGS

For Real Estate Professionals

Understand What Issues Your Homebuyers Are on the Look Out for and How to Offer Solutions

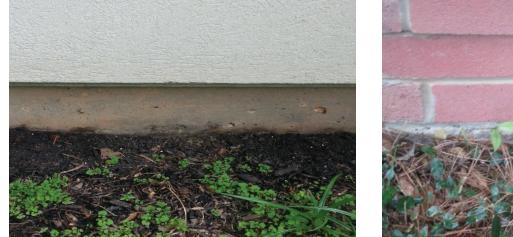
#10 - SITE GRADING AND DRAINAGE PROBLEMS

Right.

Wrong.

High grading around the foundation is one of the most common issues identified on inspection reports. The proper minimum clearance between the facade and the soil is 4 to 6 inches. High grades are most commonly found in planter areas. Homeowners often place new mulch without removing the old, creating potential issues.

Drainage problems are avoidable with proper grading. Site grading should always slope away from the foundation for at least 5 feet. Gutter downspouts should always direct the water at least 5 feet away from the foundation or deposit into a site drainage system.

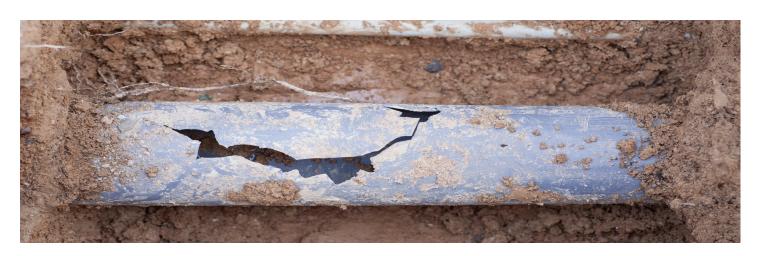
#8 - MAIN DRAIN AND SEWER ISSUES

Clogged or obstructed pipes are extremely common. Many times, underground pipes are damaged by tree roots, which are drawn to pipes for their moisture. Signs of main drain and sewer issues are floor staining or sitting water of unknown origin. Homebuyers often look for rooter or plumbing stickers, which indicate the pipes have been well-maintained.

Sewer line scans can identify any plumbing issues, giving insight to any potential repairs.

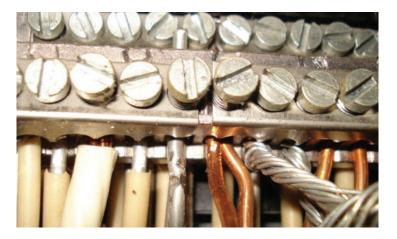
Unreliable Brands of Electrical Panels

Federal Pacific Electric (FPE) Stab-loc breaker panels and Zinsco panels are often cause for concern in the electrical industry. Many of these panels use failing breakers, causing the system to overheat.

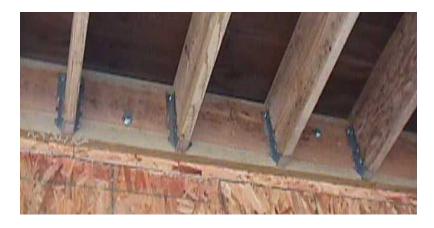
#4 - POOR DECK CONDITIONS

Poor deck conditions are often visible to untrained eyes. Check for post deterioration or chipped paint. Less obvious red flags exist in a deck's support system. Unstable support is often characterized by uneven or sloped boards.

Industry standards require all ledger boards be bolted to the house, and joist hangers must be installed on every joist with the appropriate type and amount of fasteners (left). All decks should have adequate fall protection including handrails and spindles.

Most deck issues can be self-repaired by a homeowner. For any structural concerns, a homebuyer can request an engineer consultation. Deterioration can be prevented with adequate maintenance and updated sealant.

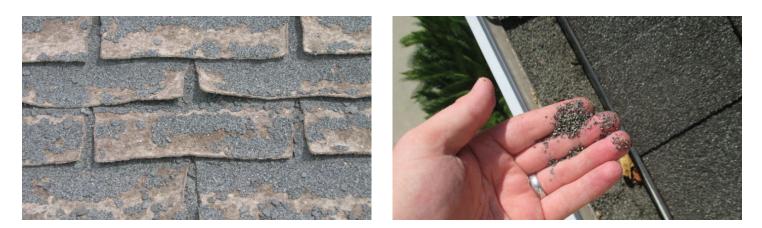
#3 - WORN ROOFING & LEAKAGE

Roof condition is often a key factor in home appraisal. Excessive granular loss (pictured above) is a key indicator of poor condition. Note that the south-facing side of a house always displays the most wear.

Replacing or repairing a roof is a significant expense for a homeowner. Buyers will avoid a house entirely if the roof is in need of repairs. The condition should always be a consideration in an offer. For older, worn roofs, a homeowner can get a Roof Certification from a roofing company or a general contractor, indicating a sufficient condition.

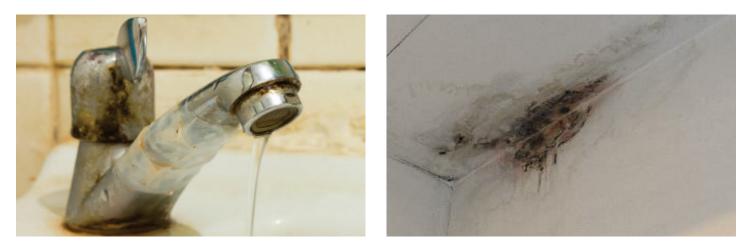
#2 - MOULD

Small amounts of mould and mildew around showers, tubs and sinks are normal (above, left). Small amounts of mould on window sills are normal and most likely caused by condensation. These do NOT present a major problem or concern.

However, mould found on walls or ceilings outside of a kitchen or bathroom DOES signal a problem (above, right). Typically, this indicates a roof or plumbing leak. Any amount of mould to the sides or below a window or door indicates a leak as well. These are definitely a major problem.

If you suspect a home has mould, encourage the owners to schedule a mould inspection immediately. Locating mould as soon as possible is key to saving thousands of dollars.
