123 Street
Winnipeg, MB R3N 1H9

INSPECTION DATE
Wednesday, July 9, 2025

Carson Dunlop - The Forman Team

Report No. 1009

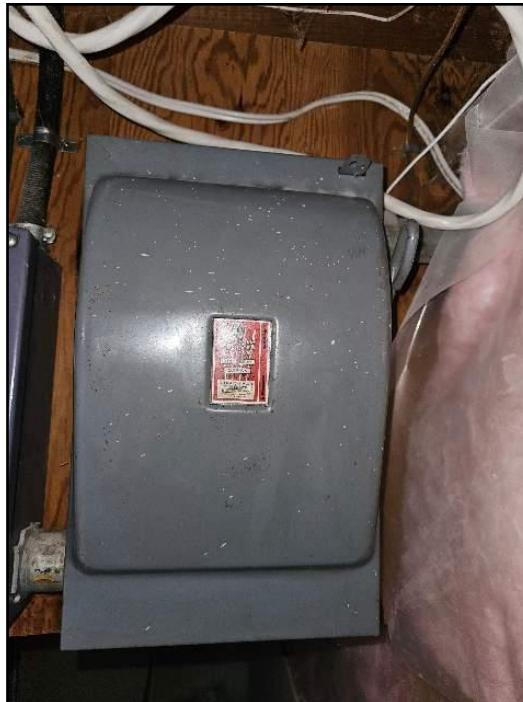
30. 100 Amps

Main disconnect/service box rating:

- 100 Amps

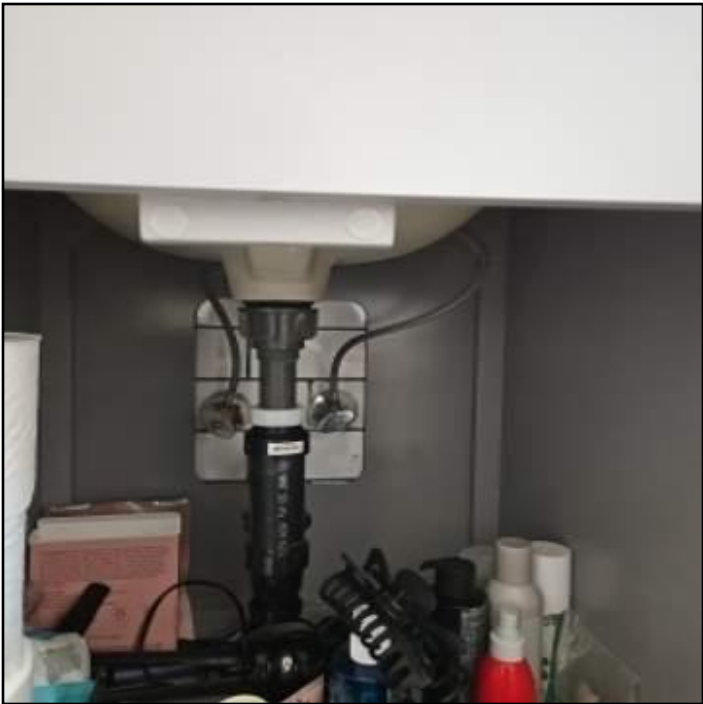
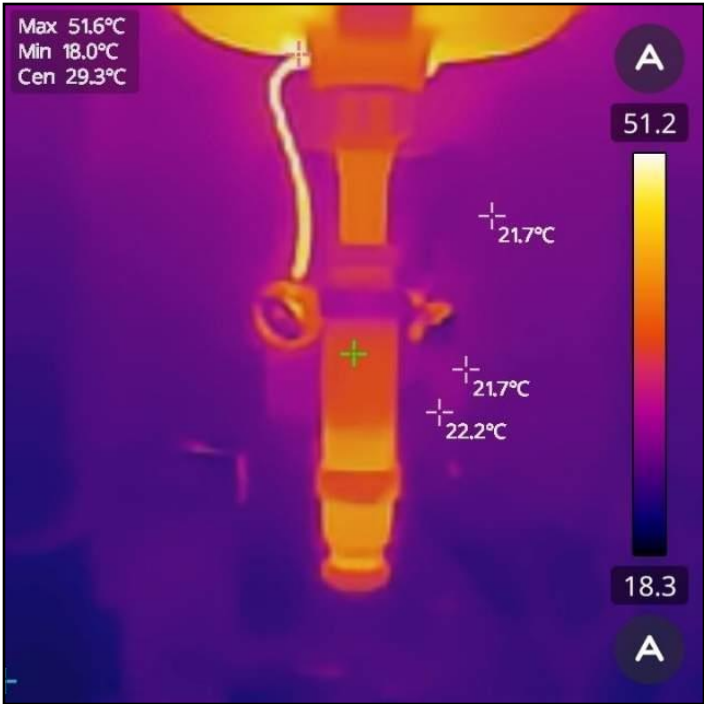
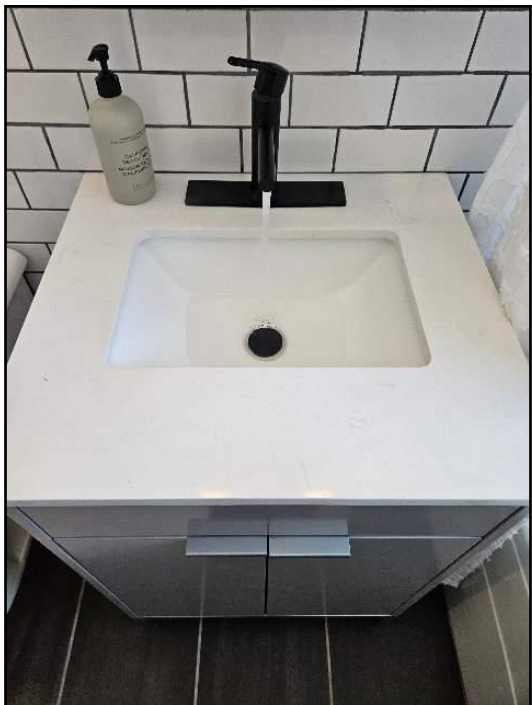
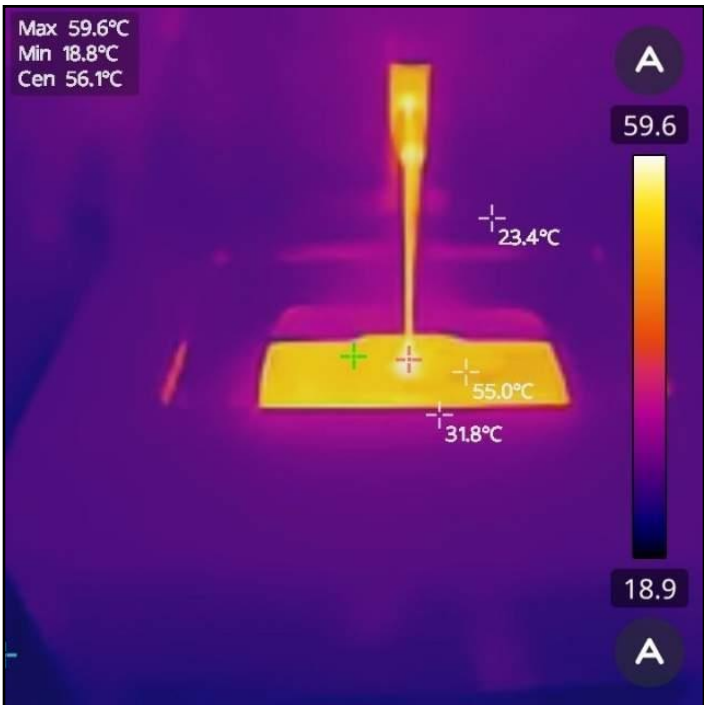
Plumbing 1: • Plumbing system has been inspected visually, using thermal camera and moisture meter; Everthing appeared to be fine except toilet drain(Please see recomendation section for more details)
