YOUR INSPECTION REPORT

Kevin Gable

Prairie Peaks Property Inspections O/A Carson Dunlop
0
Airdrie, AB T4B3X1

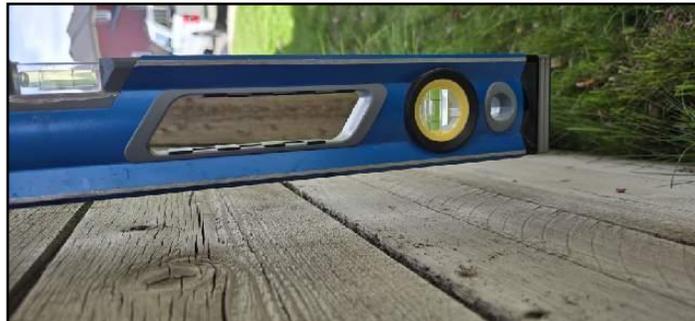
14. Wood

Retaining wall is leaning. It is showing approximately 1.5 inches over a 2 foot span out of alignment. It does not look like it is need of repair at this time. Recommend finding out who is responsible for any future repairs of the wall in the future.

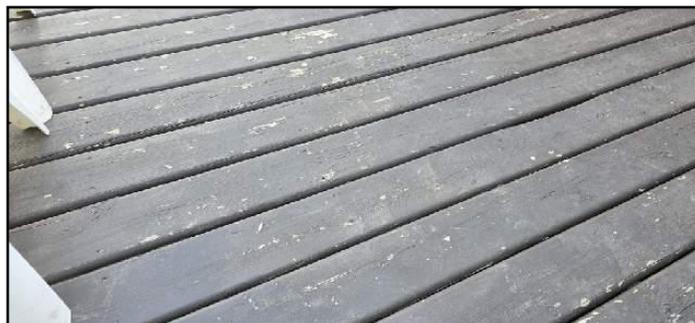
17. Raised

Deck is stable and secure. To help maintain the long-term life of the wood I recommend repainting it as some of the paint has been removed.

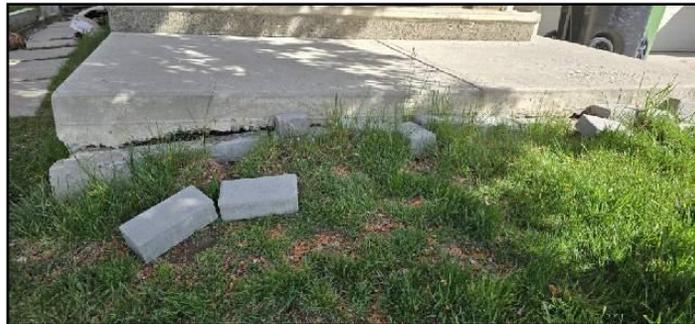
20. Concrete

Steps are solid and the railings are sturdy. A separation crack is forming due to ground settlement. Recommend contacting a concrete company about methods of stabilizing the stairs.

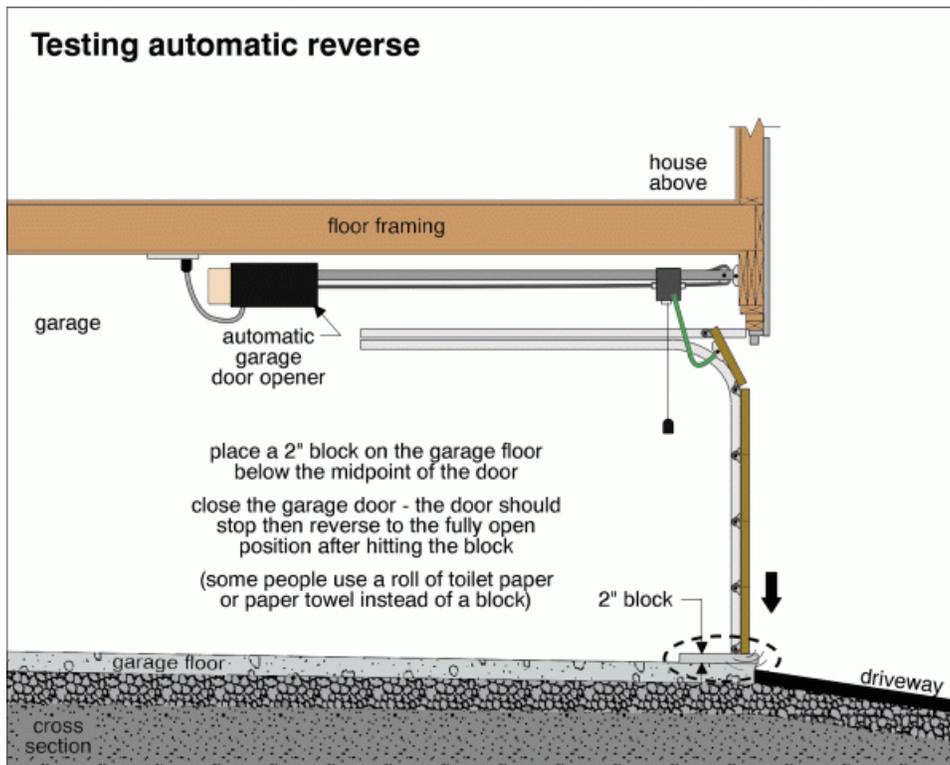
33. Fails to auto reverse

8. Condition: • [Fails to auto reverse](#)

Garage door pressure sensor does not work. Recommend repair of this safety feature.

Implication(s): Physical injury

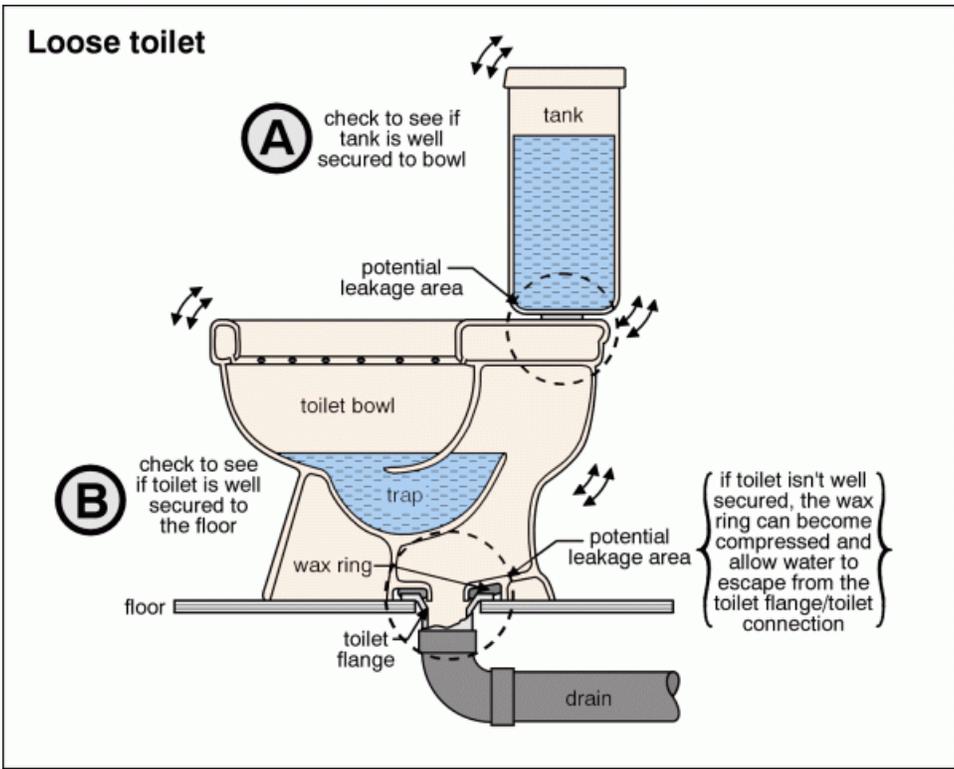
72. Loose

10. Condition: • [Loose](#)

Toilet moves side to side easily which can cause leaks. Recommend having this corrected.

Implication(s): Chance of water damage to structure, finishes and contents | Sewage entering the building | Possible hidden damage

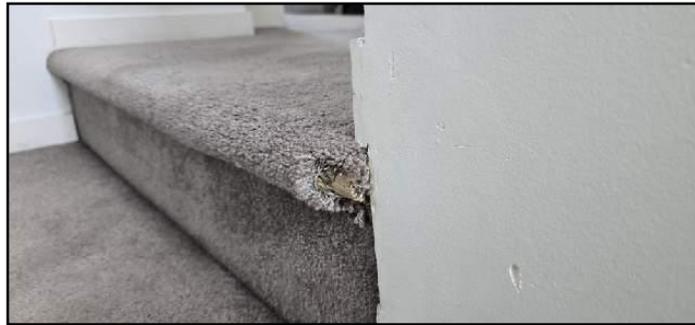
75. Carpet

I inspected the flooring for wrinkles or worn-out sections. Only one small defect found on the stairs.

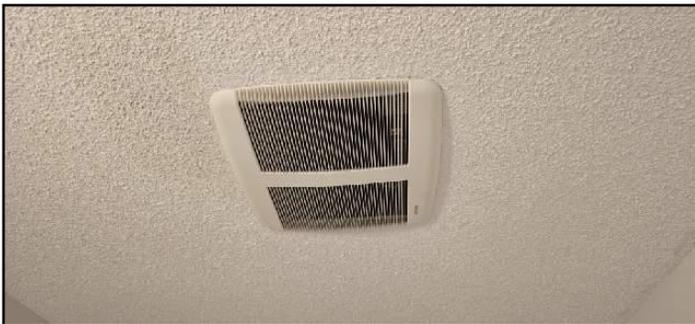
93. Exhaust fan

- Exhaust fan
Inspected and functioning. These fans meet minimum requirements. I recommend upgrading them in the future.
