INSPECTION REPORT

[REDACTED]
Calgary, AB T2Z 0S5

INSPECTION DATE

Monday, September 22, 2025

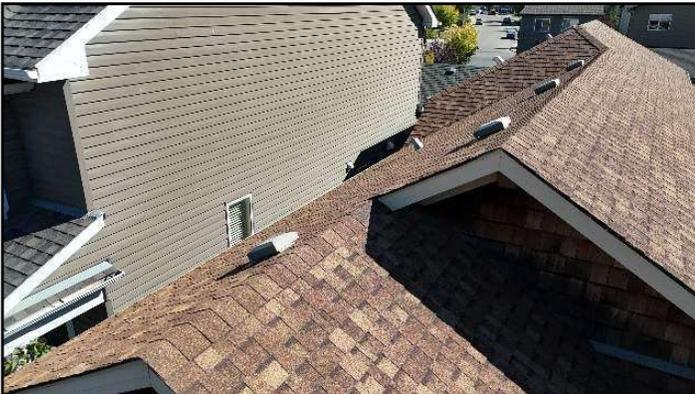
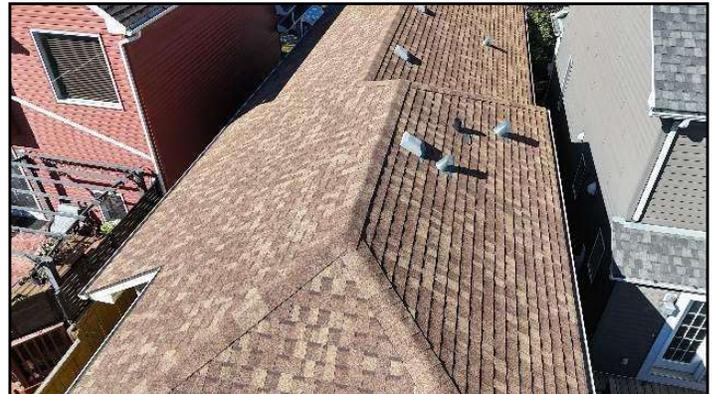
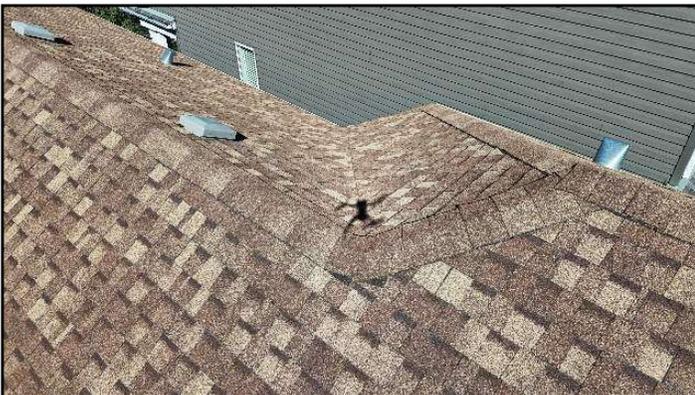
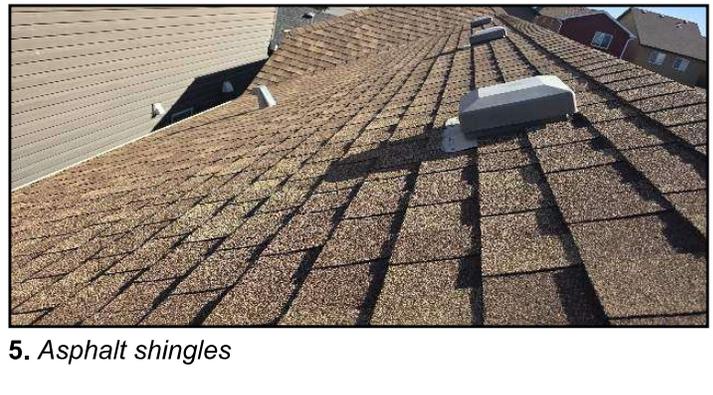
See recommendation section for areas of improvement.

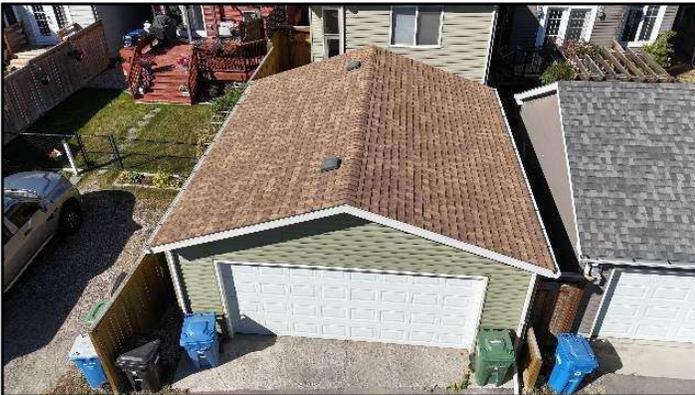
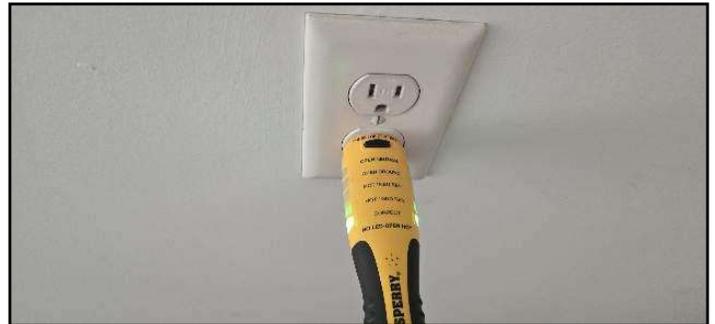
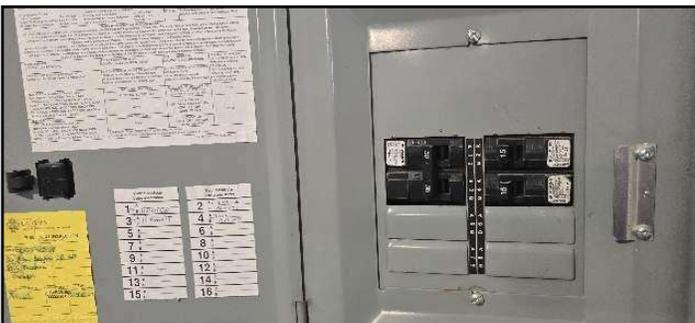
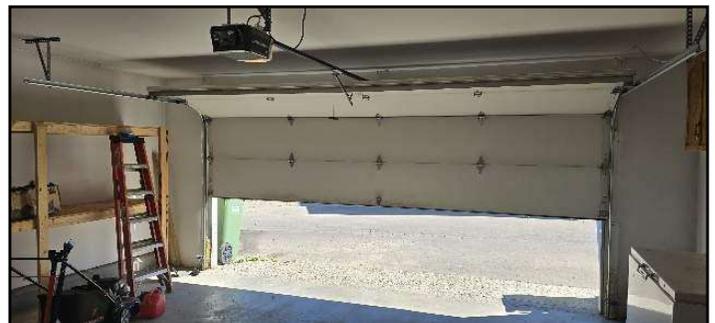
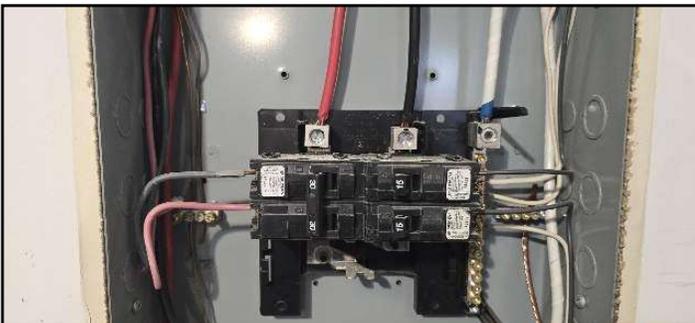
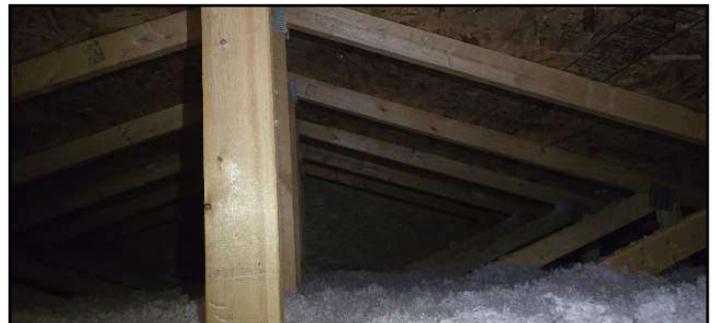
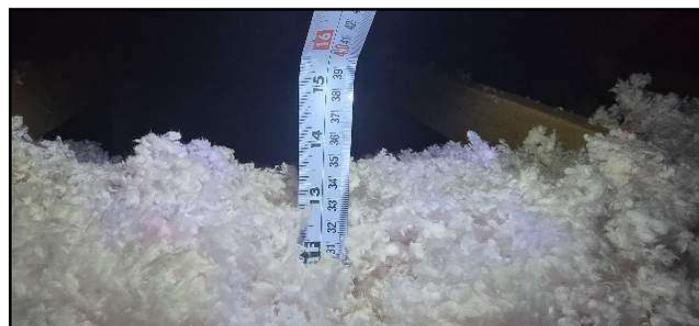
The garage was inspected and no major issues or maintenance items were found. The insulation in the attic space is sufficient and all the safety features on the vehicle door were functioning as intended. Some typical minor cracking in the

floor is present, but they are not a concern at this point. The electrical subpanel and outlets also appear to be in working order. The roofing shingles are in the same condition as the roofing on the main house, near end of life, and recommend these be replaced at the same time as the house shingles.

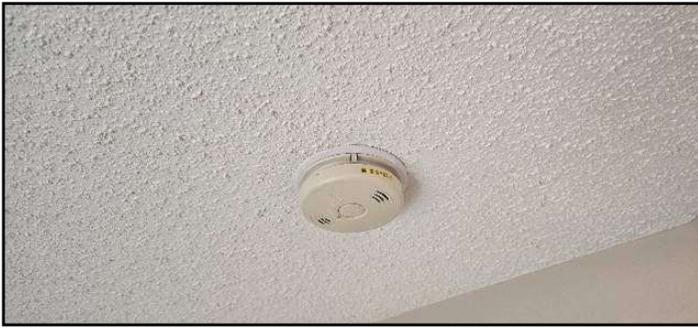
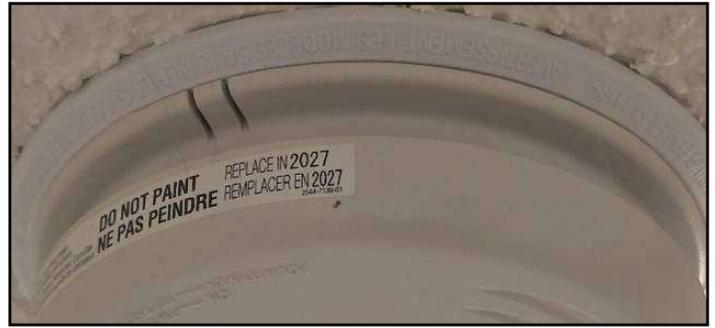
43. Present

The smoke detectors were noted during the inspection as needing to be replaced in 2027. I recommend an annual inspection and to have them replaced every 10 years at a minimum.

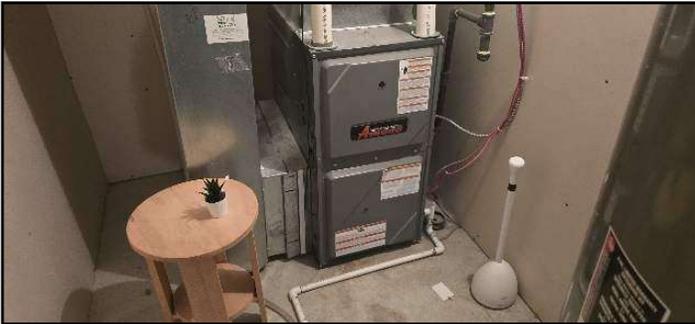
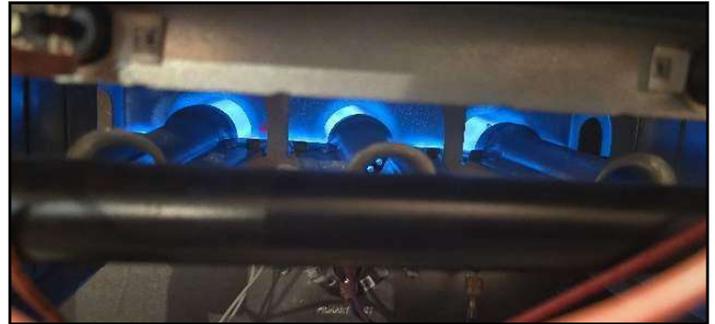
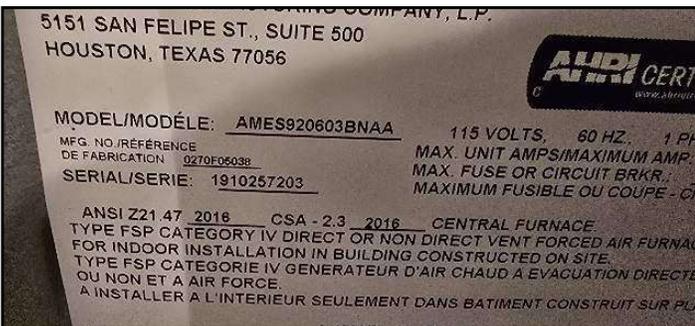
The furnace was inspected, and I found it to have a slightly delayed ignition, and the safety switch to the lower cabinet was altered. Recommend having the furnace serviced and maintained by a licensed professional. See recommendation section for areas of improvement.

Recommend the ductwork for the dryer and furnace get cleaned and serviced by a professional technician. The furnace safety switch for the lower cabinet area is not functioning. This should also be repaired.

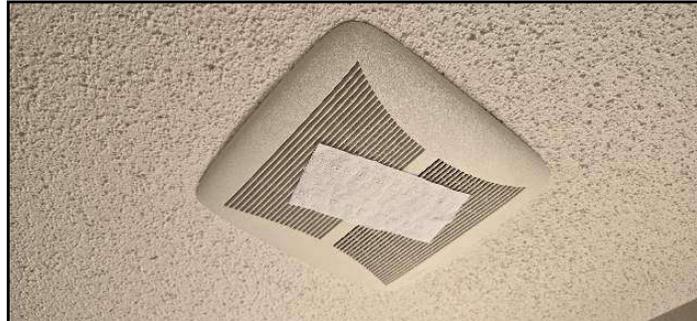
98. Exhaust fan

- Exhaust fan
- Tested and functioning

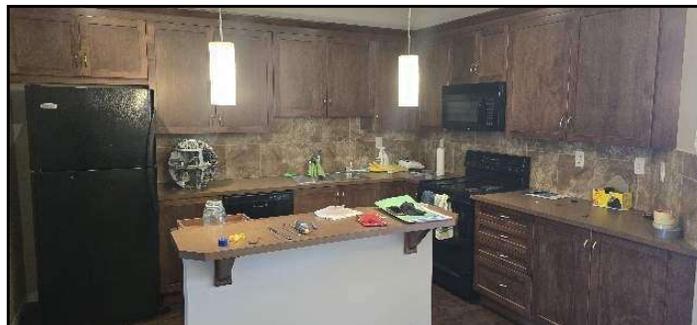
99. Inspected

- Inspected
- No issues or areas of concern.
