YOUR INSPECTION REPORT

Kevin Gable

Prairie Peaks Property Inspections

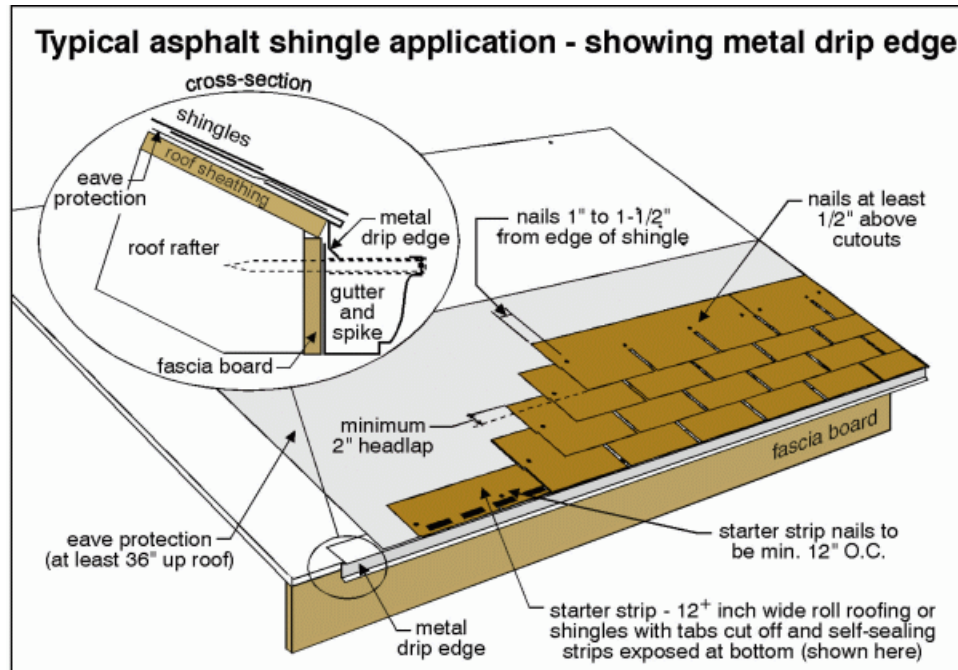
SLOPED ROOF FLASHINGS \ Drip edge flashings

1. Condition: • [Missing](#)

Implication(s): Chance of water damage to structure, finishes and contents

5. Missing

Recommend having drip edge flashing installed.

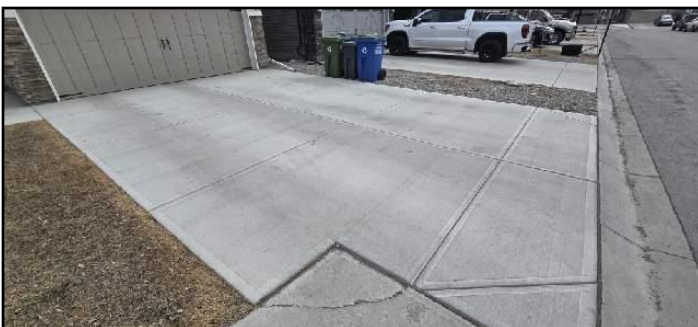
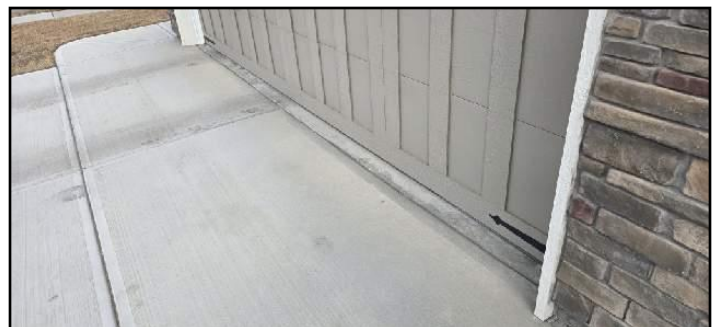
No cracks, settlement or issues found with the Driveway

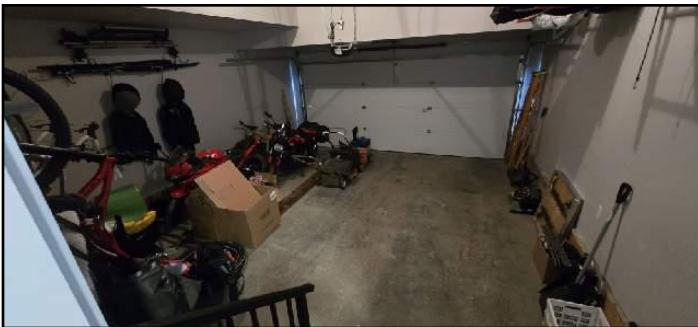
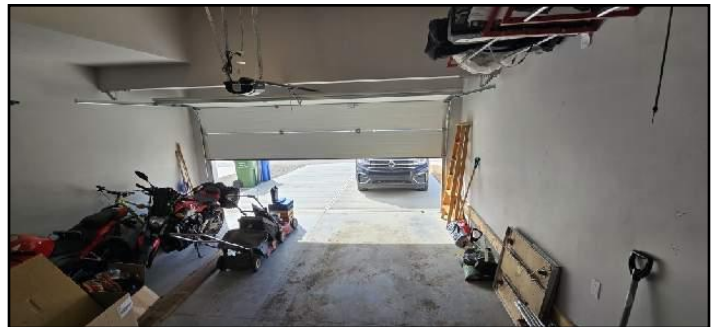
The operations and safety features of the garage door were tested and no faults could be found.

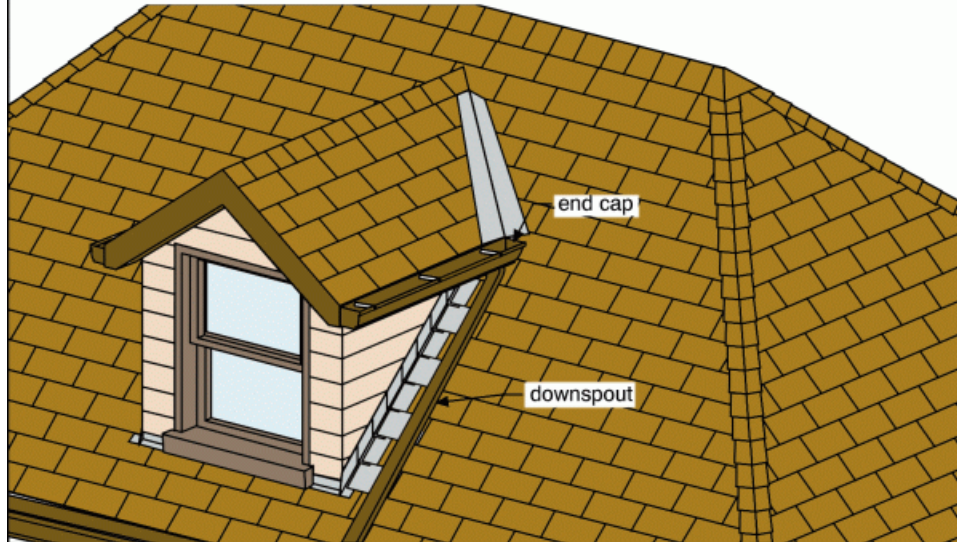
3. Condition: • [Discharge onto roofs](#)

Discharge of the downspouts on to a lower roof can shorten the life of the shingles in that area do to the volume of water. It's best practice to continue the downspouts to the eaves when you can to give your roof and the shingles a longer life.

Implication(s): Chance of water damage to structure, finishes and contents

Downspout running across roof

18. Discharge onto roofs

installing a downspout (from the secondary roof to the main gutter below) helps prevent localized roof wear

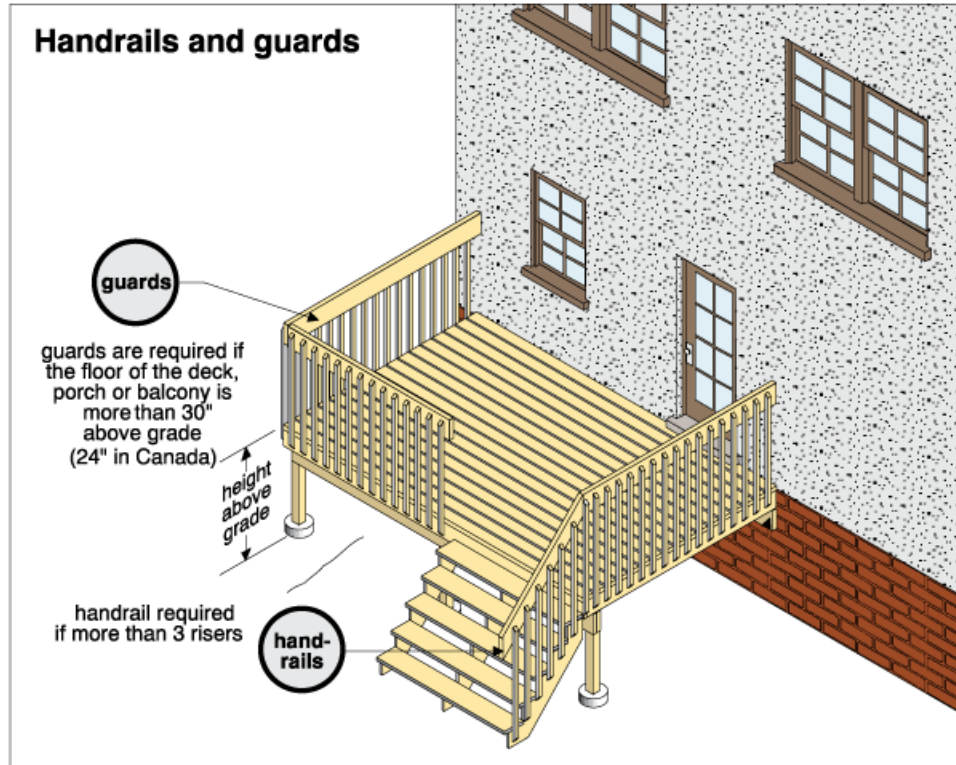
5. Condition: • Missing

Implication(s): Fall hazard

22. Missing

Recommend having railing installed at the steps and around the deck for safe use.

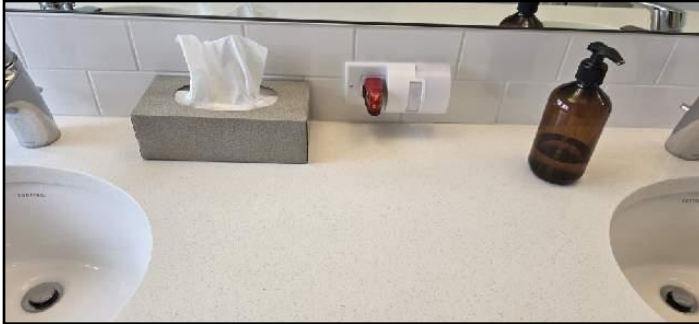
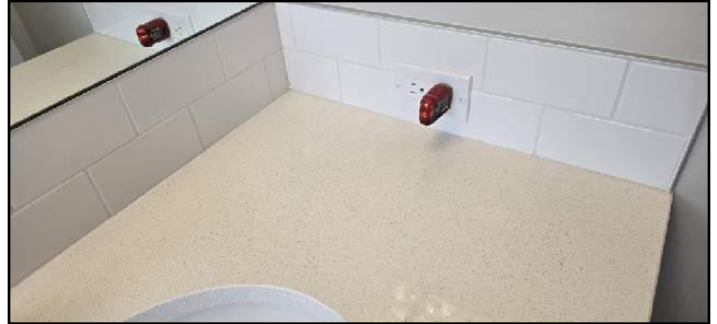
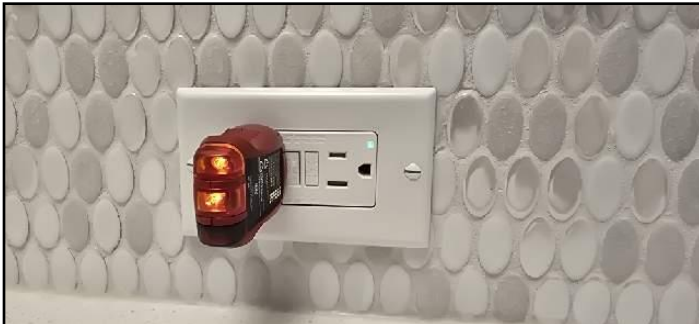
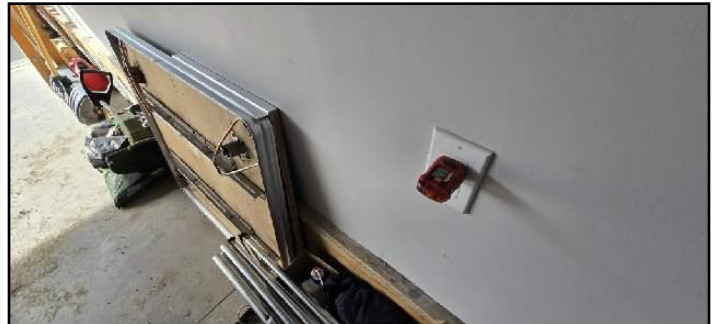
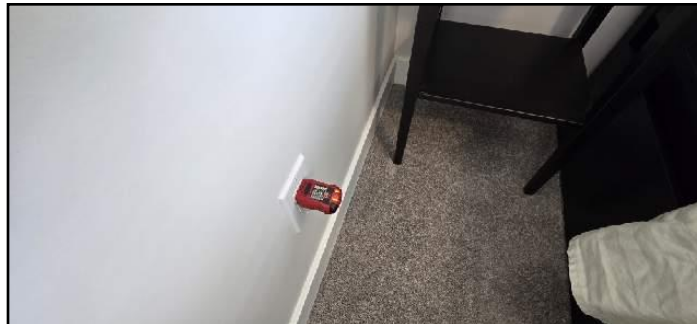
General: • A large sampling of outlets both inside and outside were tested and no faults could be found. All GFCI outlets are in the right places and functioning. Only one outlet needs additional attention. Information about that can be found further on in the report.

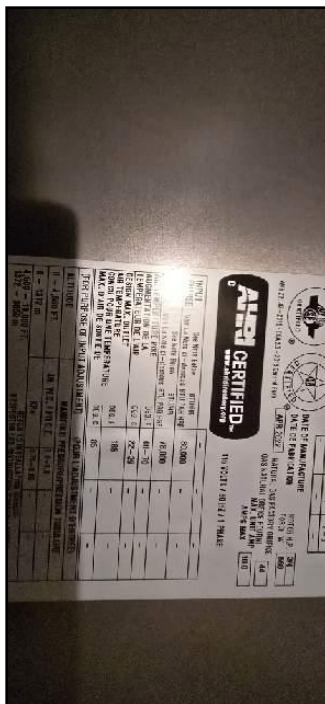
42. Furnace

The furnace is functioning well. However when I was inspecting the furnace I could detect a small gas odor. I checked with my Tiff for signs of a gas leak and found positive readings. This can be a a common thing with high efficiency furnaces. I recommend having the furnace serviced by a professional to ensure proper functioning.

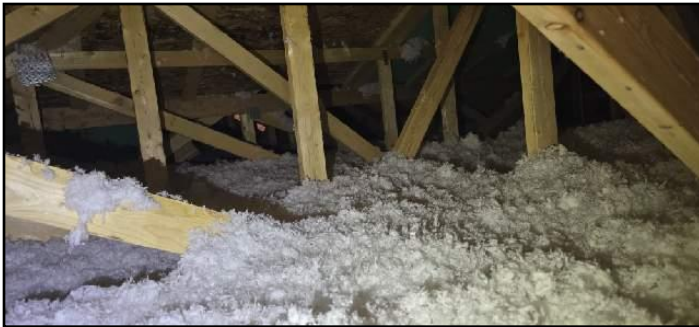
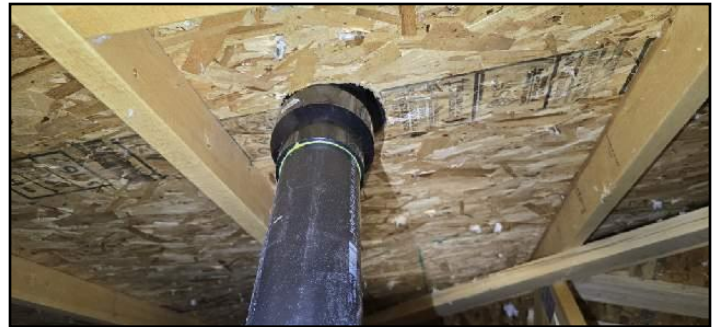
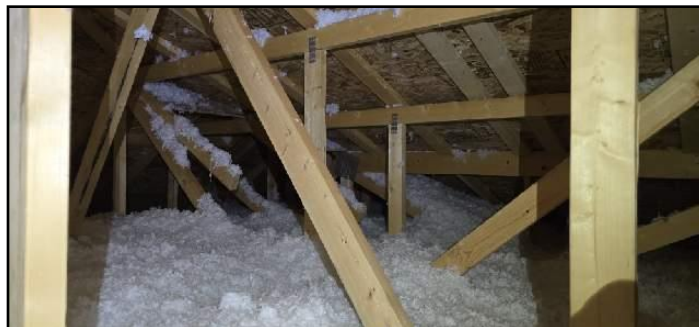
General: • Attic space was inspected and no signs of water intrusion or attic rain could be found. Thermal imaging from below was used to verify. This indicates proper use of venting and vapor/moisture barriers.

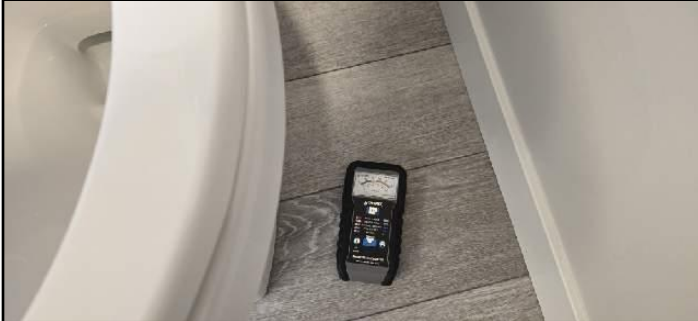
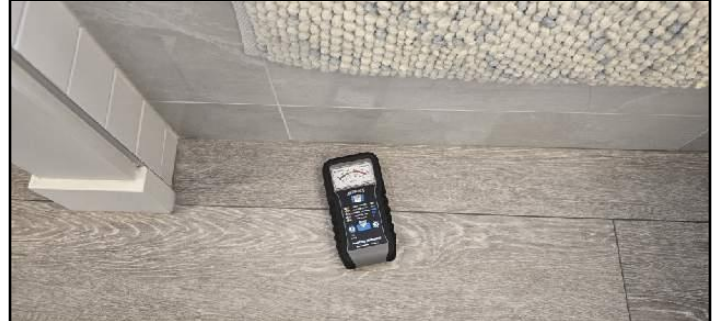
General: • Inspection performed with thermal imaging and moisture meter in all bathrooms and under sinks. No faults or leaks detected in the system. Hot water is working and at the recommended temperature.

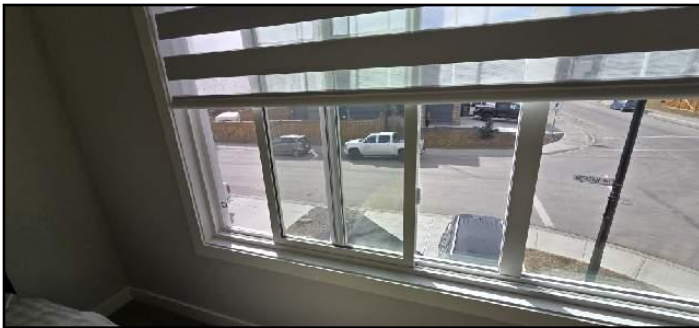
64. Sliders

A large sampling of windows were tested and checked for defects and no faults could be found.

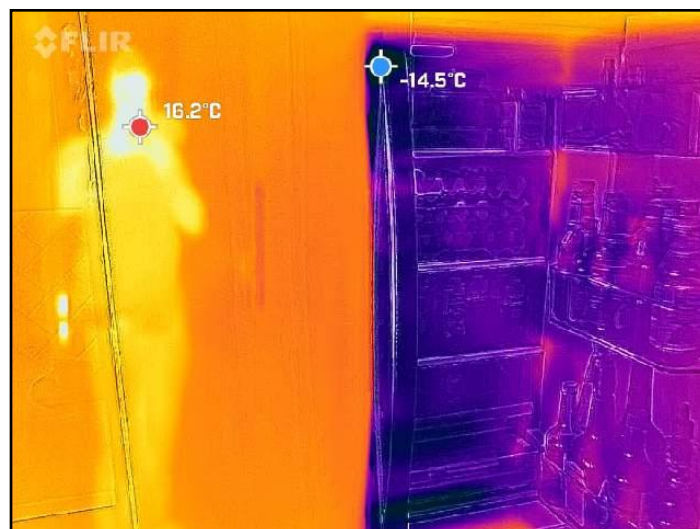
69. Refrigerator

All kitchen appliances were tested and double checked with thermal imaging for efficiency. No faults found with any of the appliances.

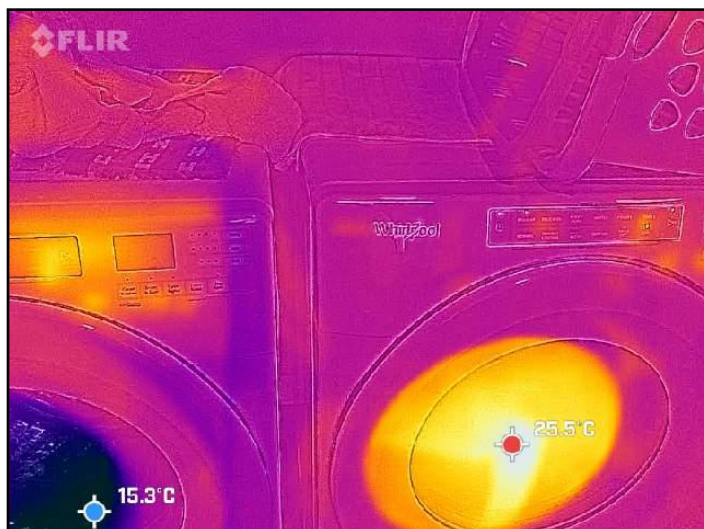
75. Dryer

The washer and dryer were tested and no faults could be found. It is noted though that there does not appear to be a floor drain in the laundry room area. It is best practice to have one in this area to help minimize any damage and protect the property if the washer does develop a leak.
